SOCIETY FOR ECOSYSTEM RESTORATION  
IN NORTHERN BRITISH COLUMBIA

## **Bulkley River and Morice River Watershed Groups Fish Passage Restoration Planning 2021**

**Prepared for  
Habitat Conservation Trust Foundation - CAT21-6-288  
BC Fish Passage Remediation Program  
Canadian Wildlife Federation**

**Prepared by  
Al Irvine, B.Sc., R.P.Bio.  
New Graph Environment Ltd.  
on behalf of  
Society for Ecosystem Restoration in Northern British Columbia**

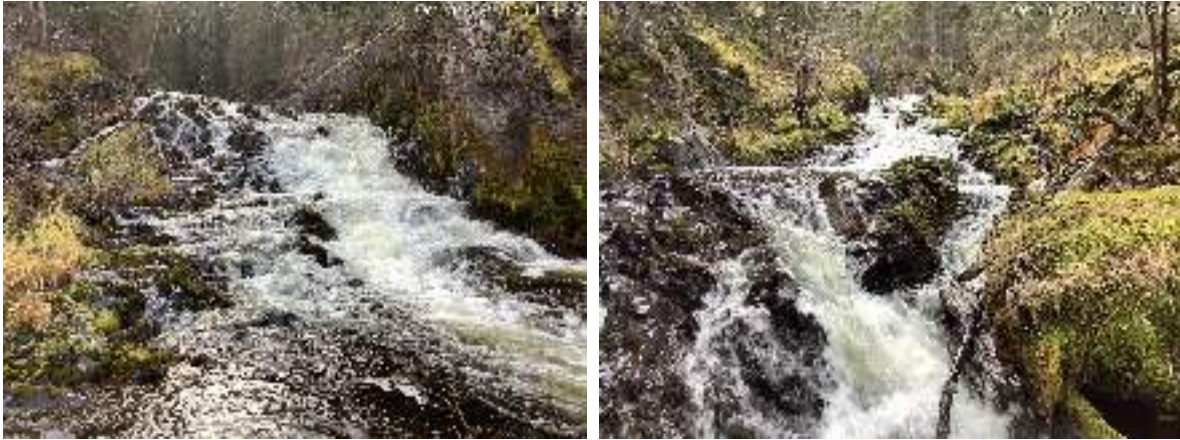
Dyson (1949) and Stokes (1956) report substantial use of habitat above Bulkley Falls by steelhead, chinook, coho and sockeye utilization in the past (pre-1950) based on spawning reports. Both authors concluded that the Bulkley Falls pose a partial obstruction to migrating fish based on flow levels. Chinook, which migrate early in the summer when water levels are high, have been noted as able to ascend the falls in normal to high water years and in high water years it was thought that coho and steelhead could ascend. A. Gottesfeld and Rabnett (2007) report that the falls are almost completely impassable to all salmon during low water flows. Stokes (1956) reports that there was high value spawning habitat located within the first 3km of the Bulkley River from the outlet of Bulkley Lake.

Figure 4.1: Left: Bulkley Falls main channel. Right: Bulkley Falls side channel.

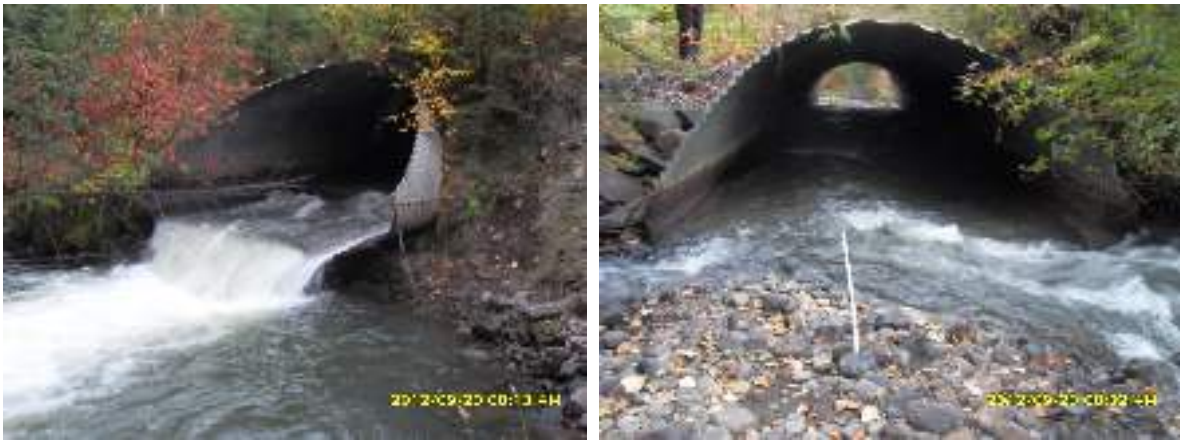
Figure 5.4: Left: Outlet of PSCIS crossing 57944 in 2012. Photo from PSCIS. Right: Inlet of PSCIS crossing 57944 in 2012. Photo from PSCIS.

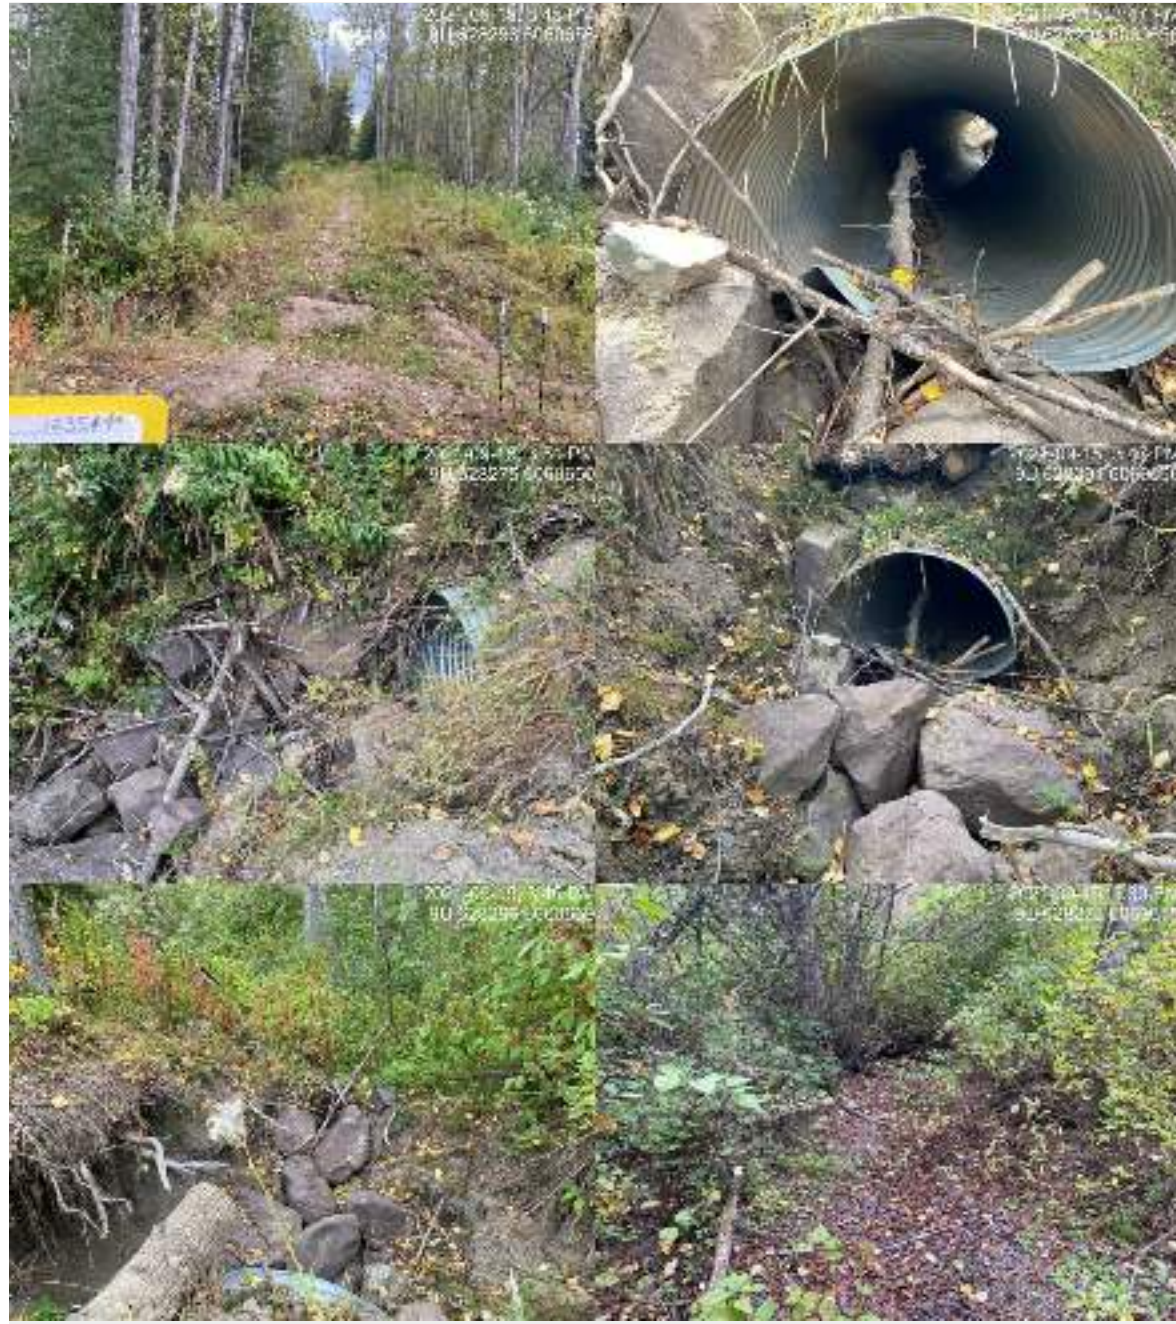
Comments: Inlet of culvert is ~5m elevation more than upstream channel. Road has filled in the creek. 15:44

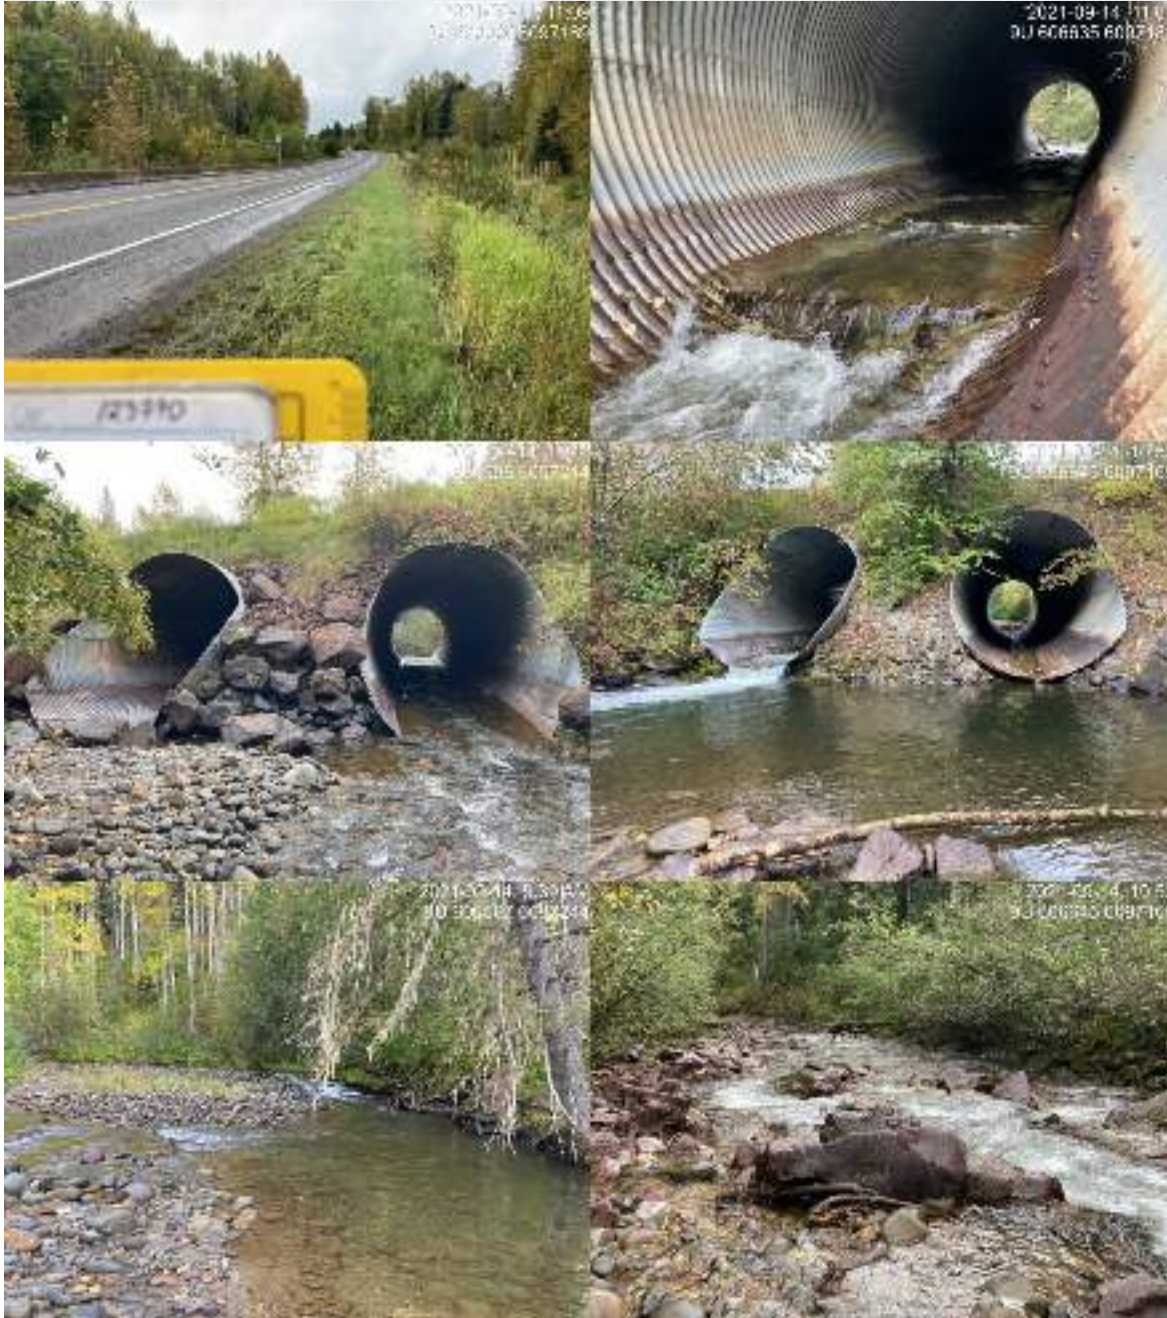
Comments: Both pipes have outlet drop and water flowing through. Water depth in left pipe is 0.01m, left pipe no embedment. Inlet drop only on right one. Also has baffling with substrate but baffling not in place for downstream ~3m, so not continuous. Estimated pool depth. 10:52

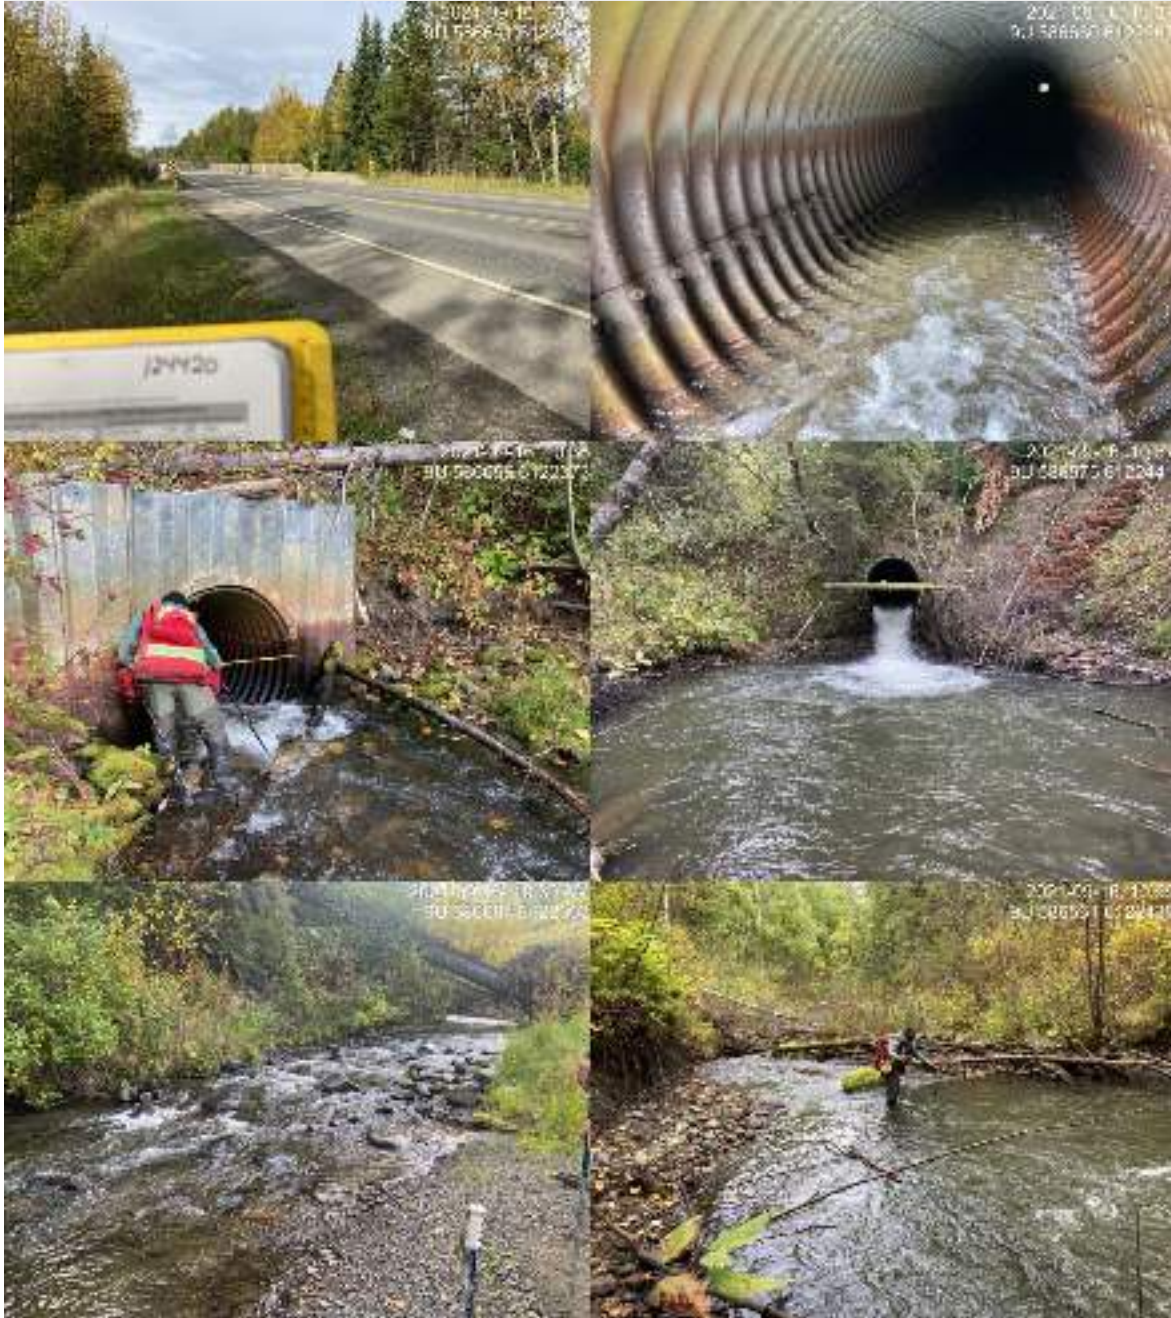
Comments: Majority of culvert is ~3% however last 5 m steepens to 6-7%, appears to be because exposed section is bending from weight of water. Fill depth ~24m. Huge pool appears it would require a lot of material to backwater and build up. 10:30

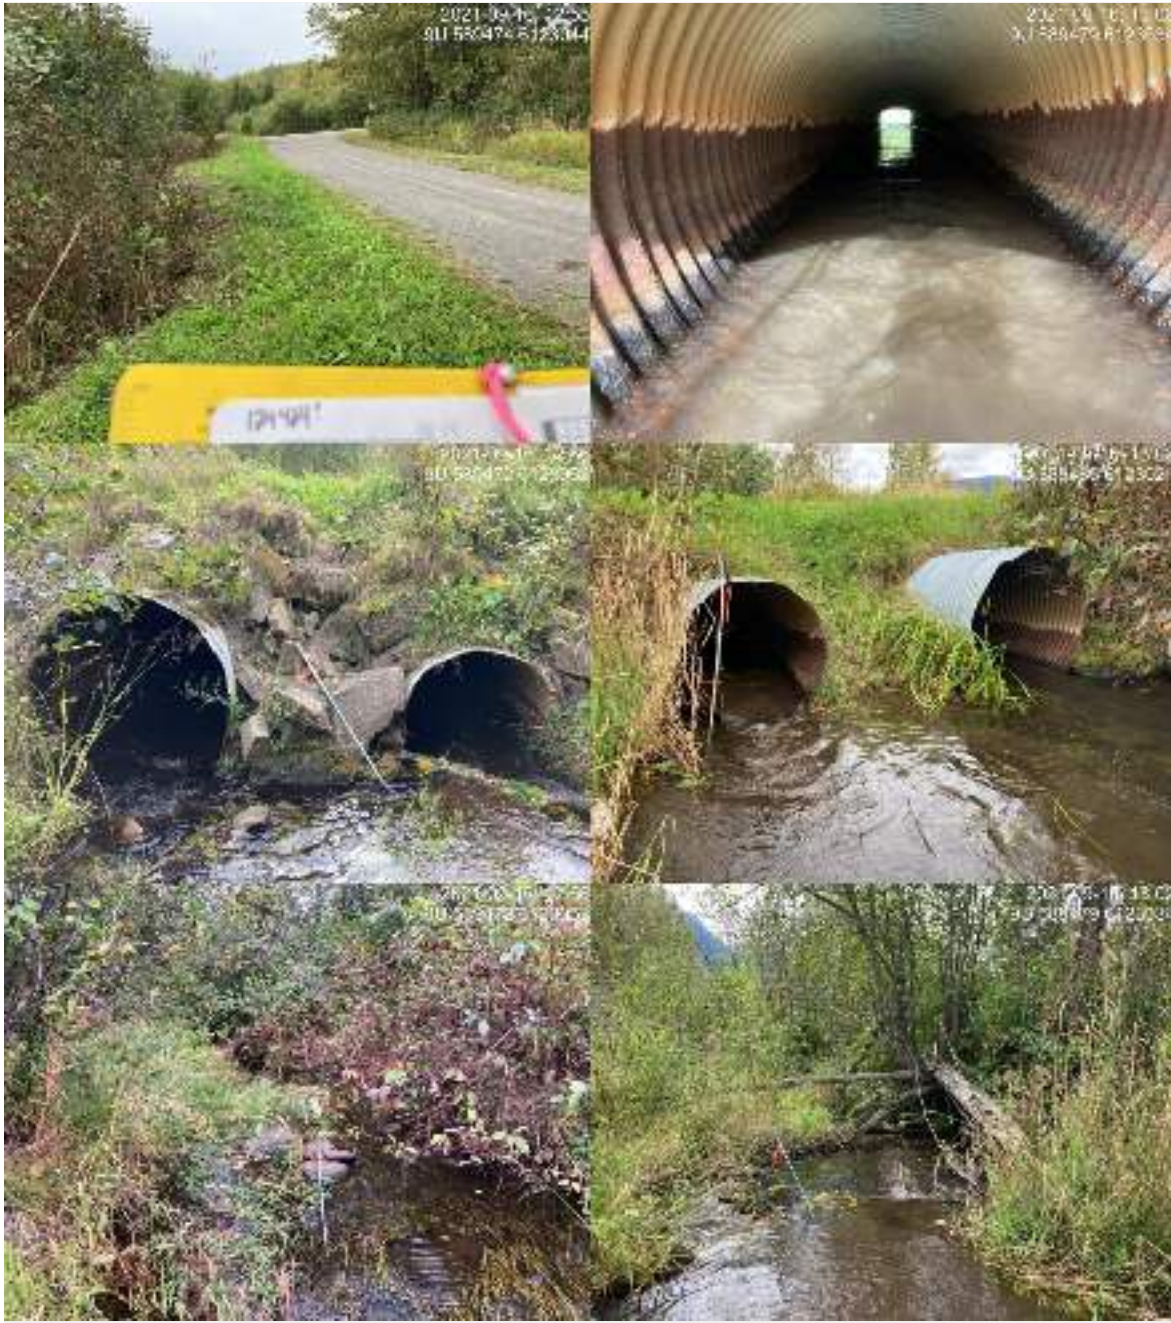
Comments: Bent in middle from road weight. Inlet drop of 0.10 for both pipes. Slow steady flow almost wetland habitat above and below. Water is high. 12:54

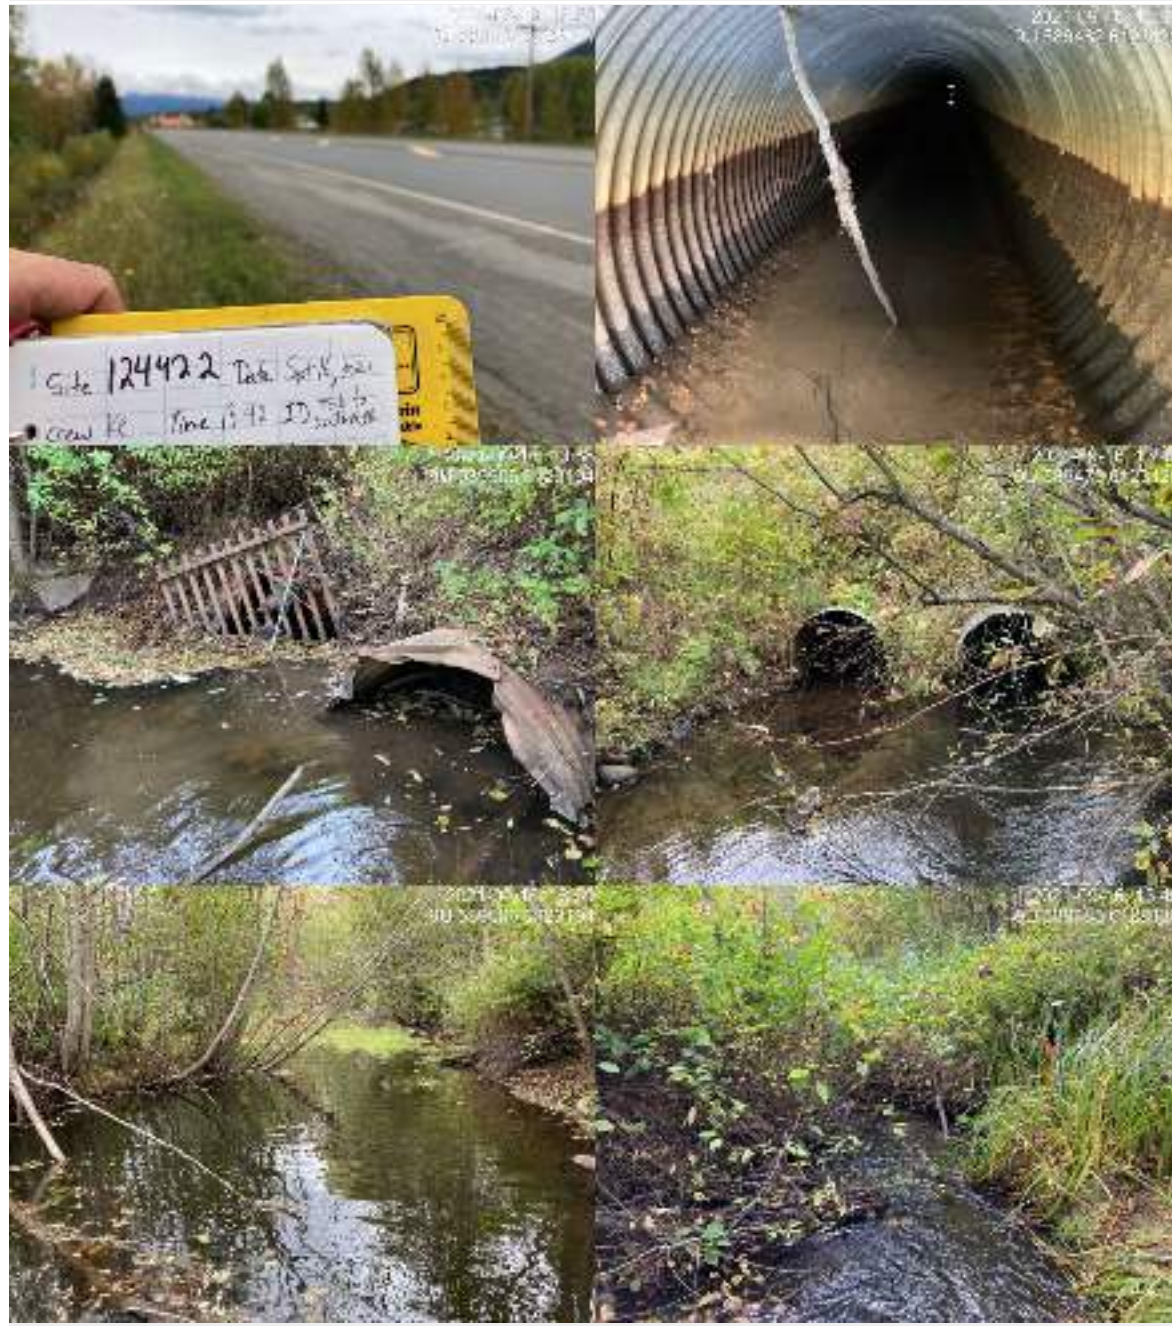
| Location and Stream Data | Crossing Characteristics |
|---|---|
| <p>Comments: 2 pipes. Both have water, left bank one is flowing. Assessment comments indicate right bank pipe is backwatered 100% but changed to 25% based on photos and past PSCIS data and photos which also indicated not backwatered. Suspect blockage due to debris. Outlet water depth, fish sighted in outlet of right barrel. 13:42</p> | |

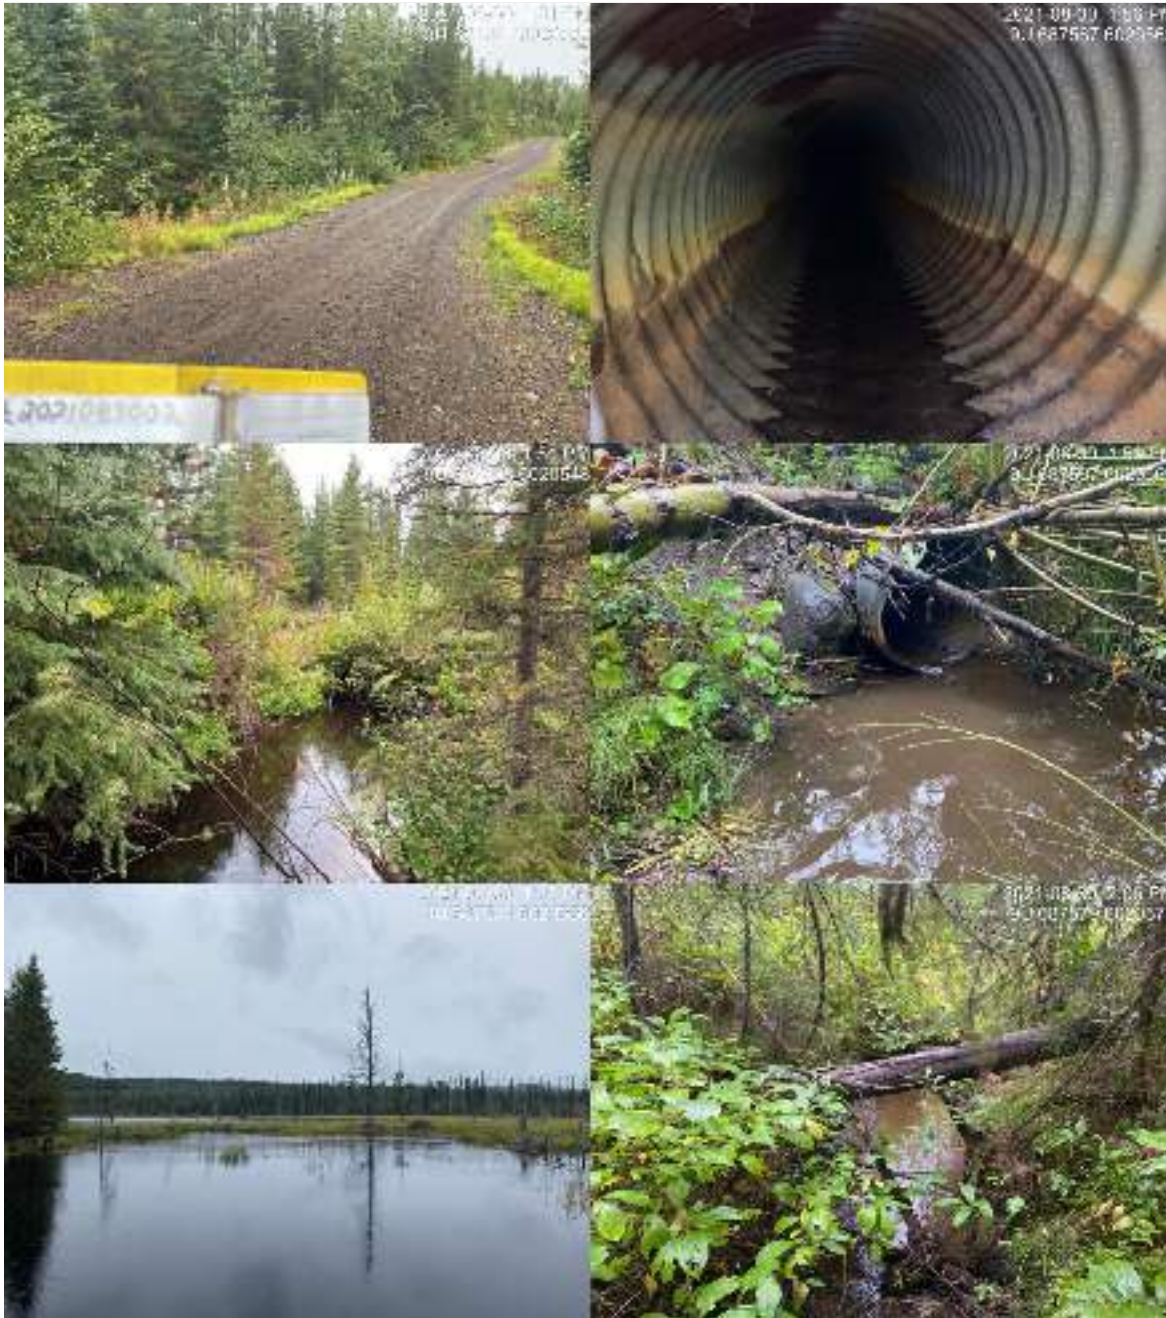
Comments: Habitat value is low to medium. Large beaver influenced lake upstream with two dams ~1.5m high at 10m and 30m upstream. Inlet blocked. Water at inlet is level with the top of the culvert. At 4m downstream is a 1m high beaver dam. 13:23

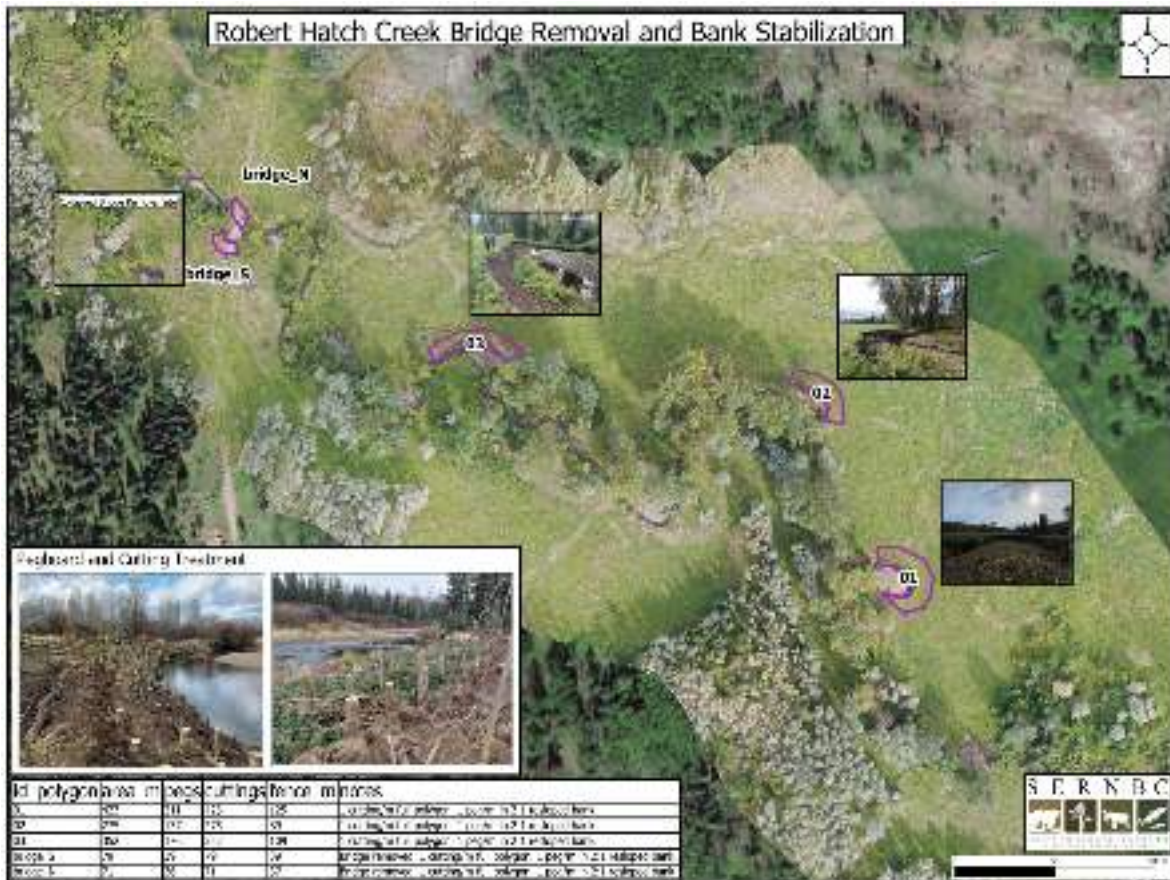
Figure 5.22: Restoration plan for Robert Hatch Creek including removal of collapsed bridge, resloping of banks and the installation of live cuttings/pegboarding

Should restoration/maintenance activities proceed at the site, removal of PSCIS crossing 197912 is recommended. In addition to removal of the collapsed bridge, resloping of banks and the installation of live cuttings/pegboarding is recommended in three areas downstream where cattle trampling is resulting in significant erosion. A map of the erosion areas and associated prescriptions for rehabilitation of the downstream corners is provided as Figure [5.22](#). The cost of the work is estimated at \$30,000 for a cost benefit of 924 linear m/\$1000 and 3973.2 m<sup>2</sup>/\$1000.

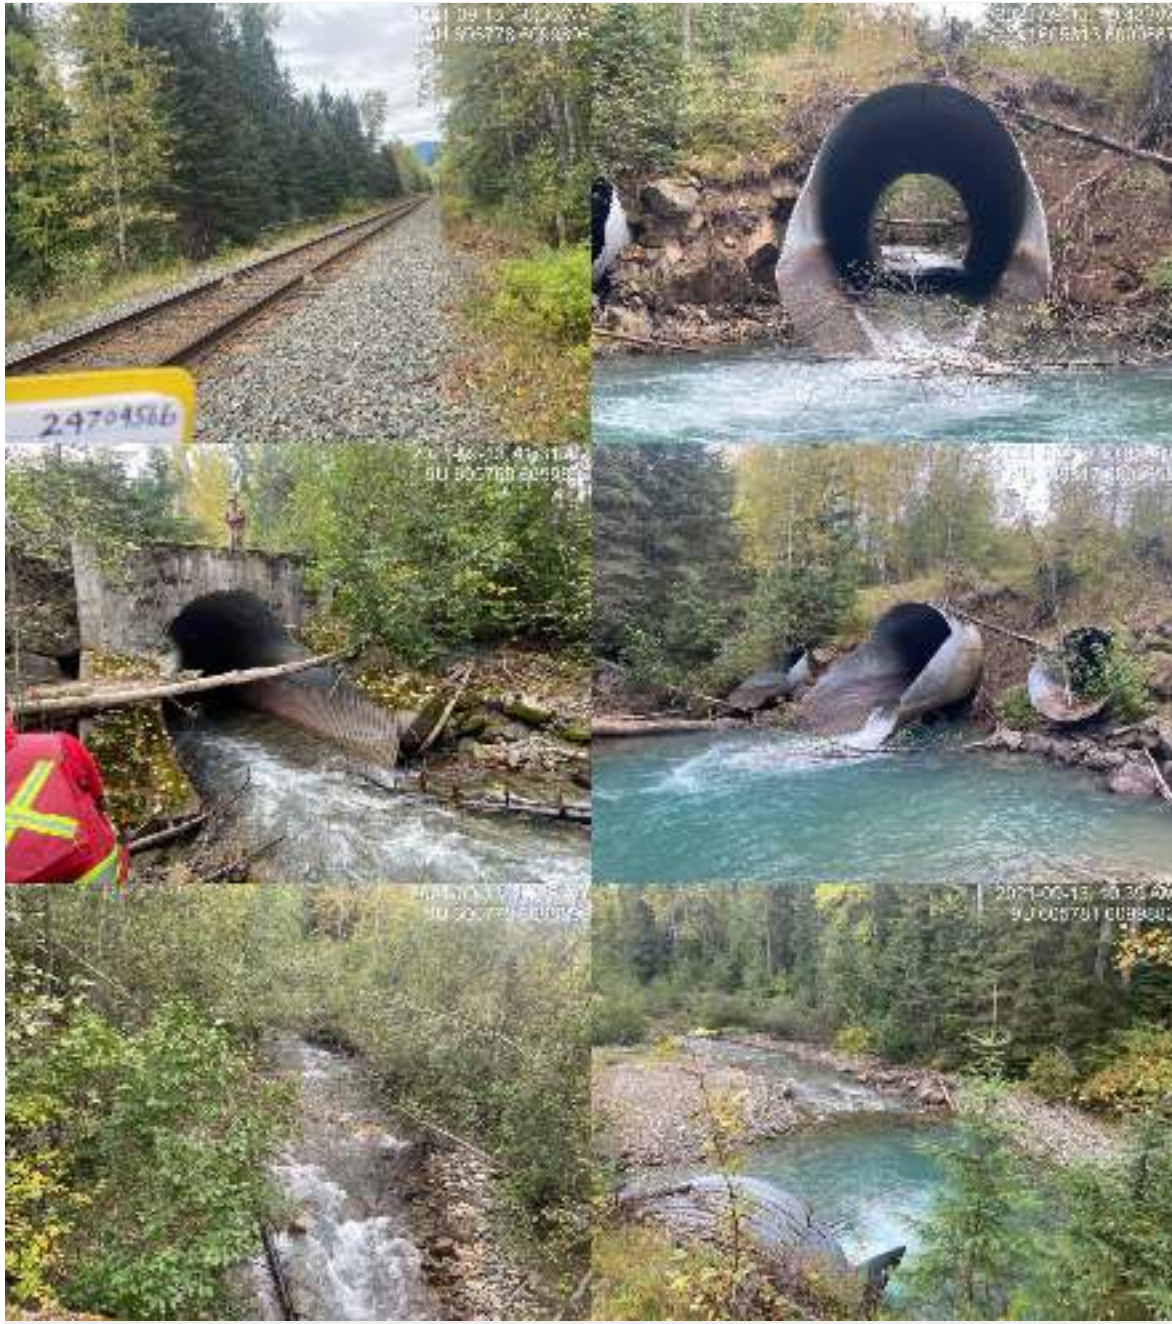
Comments: Outlet is cracked and drops. Inlet embedded to 2/3 way. 10:33

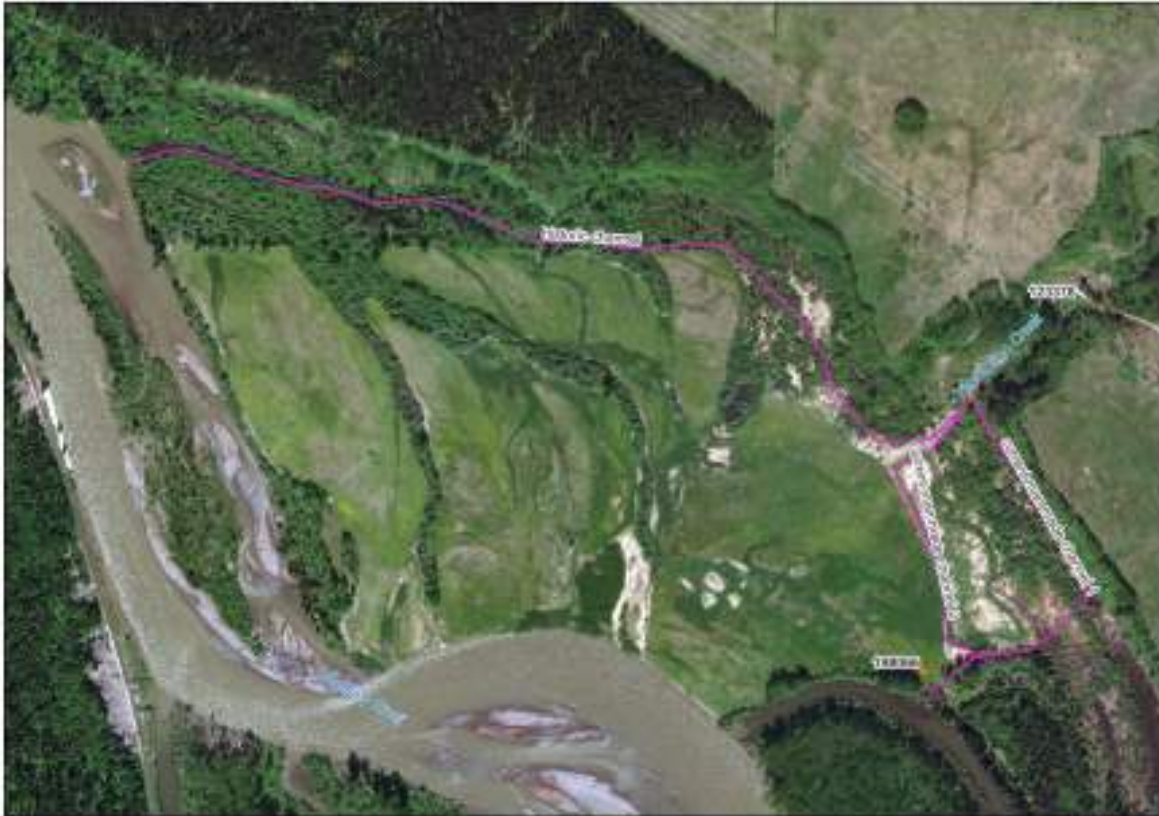
Figure 5.45: Map of the current man made channels and the historic channel on Thompson Creek adjacent to the Bulkley River.

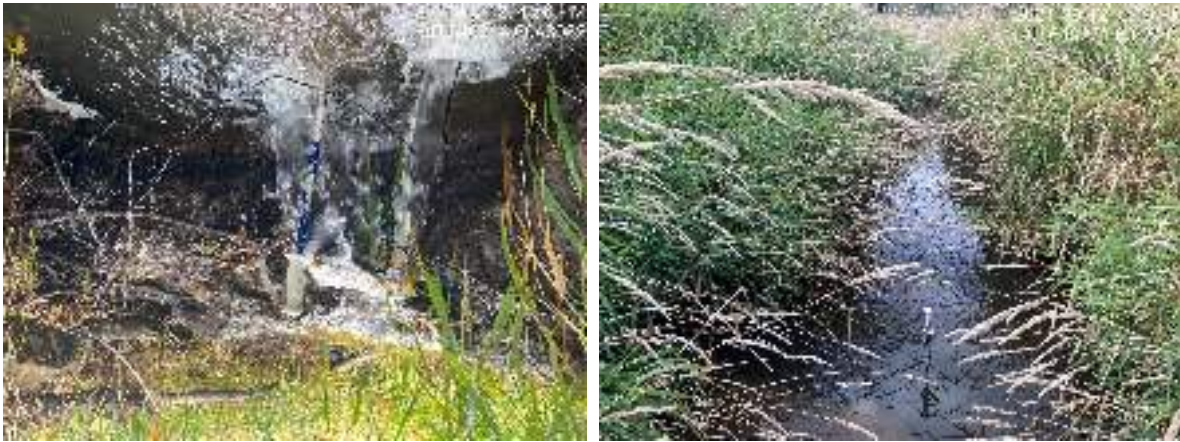
Figure 5.47: Left: Small drop (50cm high) located ~20m upstream of PSCIS crossing 198066. Right: Habitat immediately upstream of PSCIS crossing 198066 that flows through a hay field within an excavated trench for approximately 350m.
