Quintette Caribou Habitat Restoration Program: 2019 Implementation Report

DRAFT REPORT

January 31, 2019

Marc Steynen,
Society for Ecosystem Restoration in Northern BC (SERNbc)

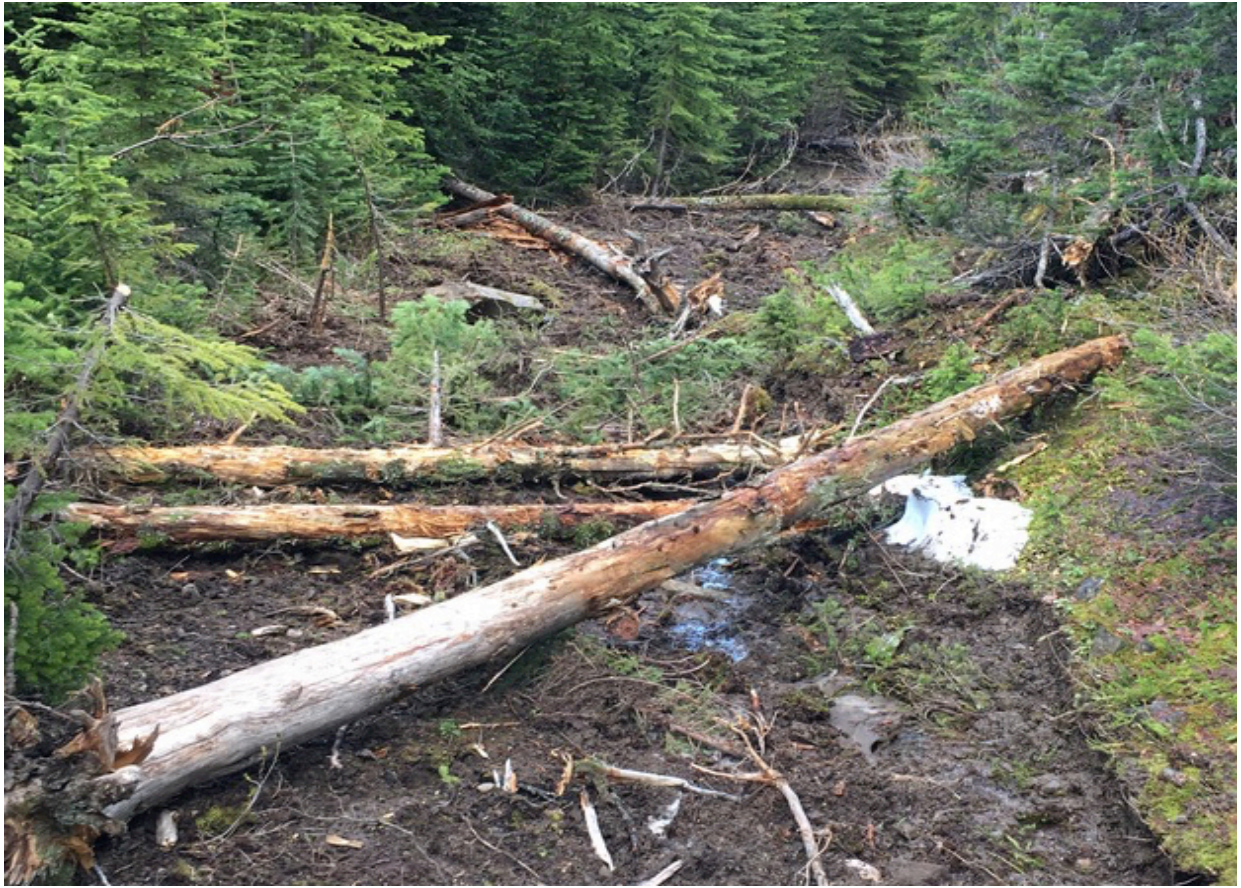
Photo 5: Machine screening and debris placement on Line Segment # 27.

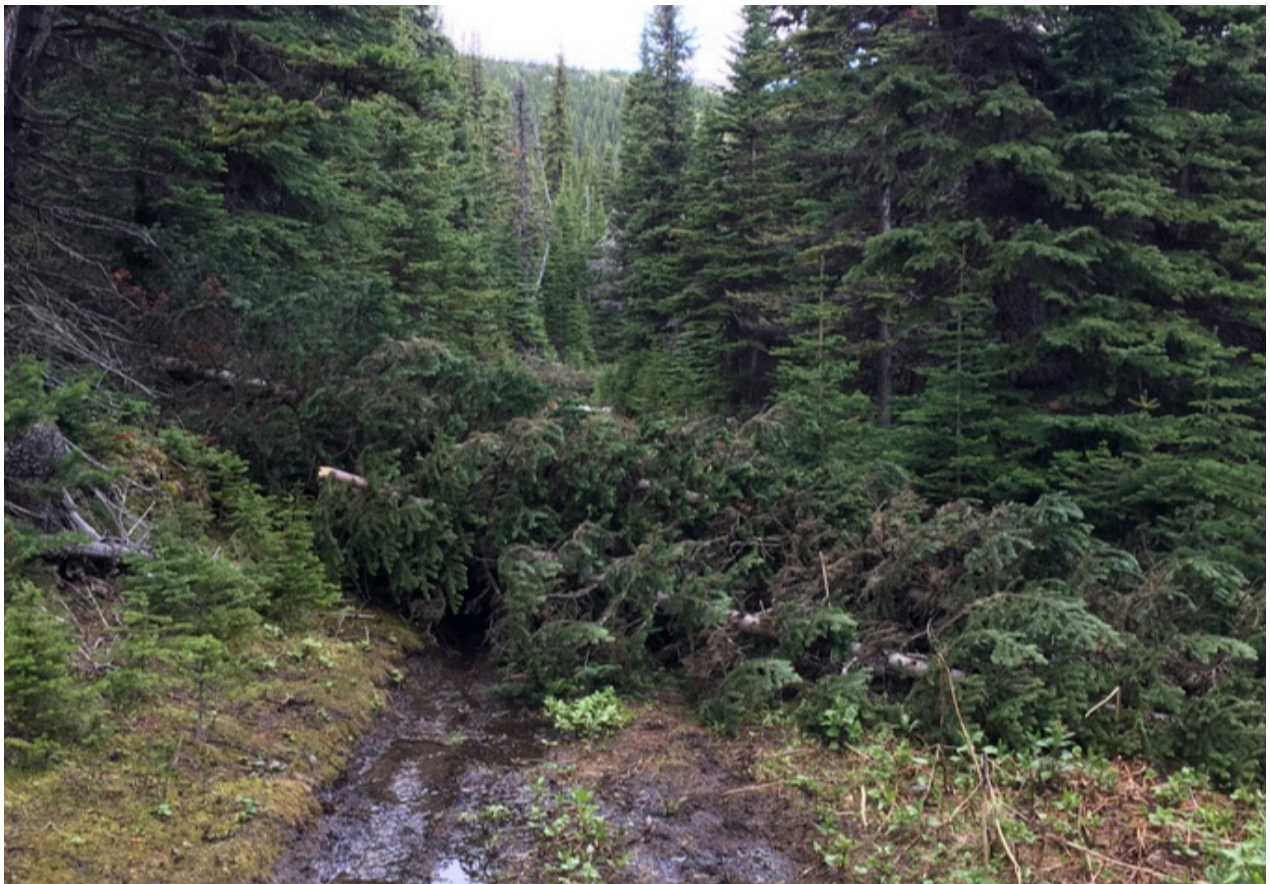
Photo 6: Tree-Felling Treatment on Line Segment #51

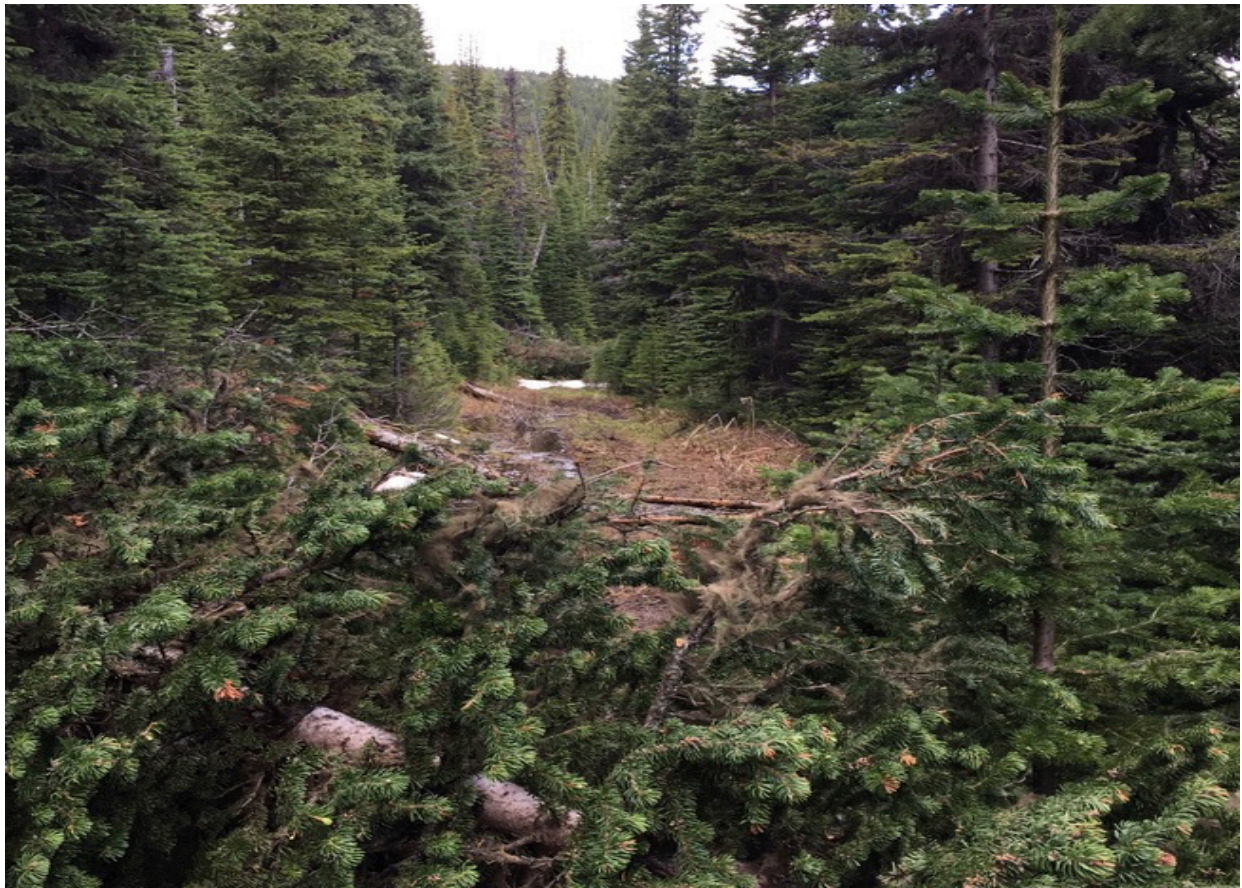
Photo 7: Tree felling at the end of Line Segment #43

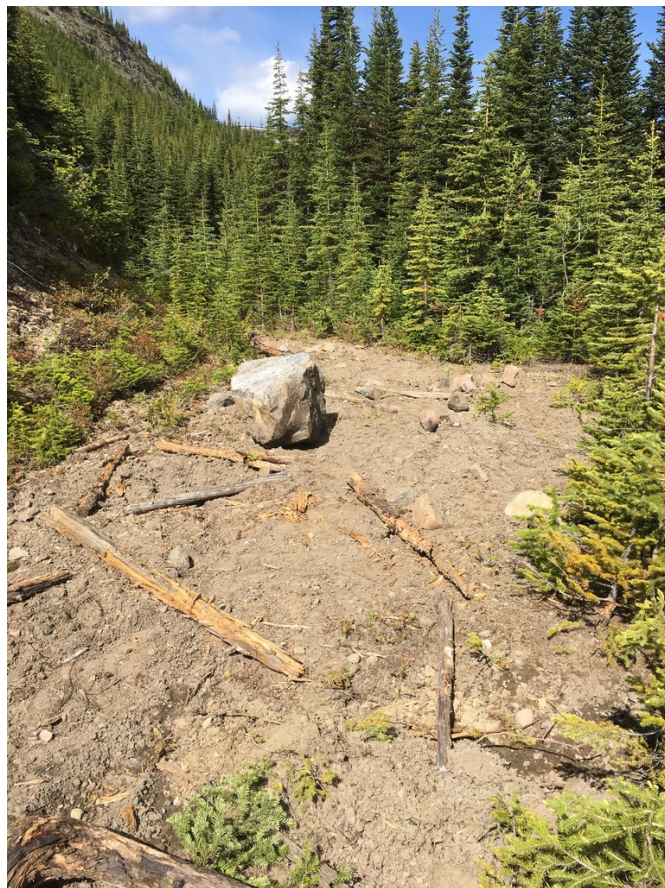
Photo 8: Machine screening on Line Segment #33.

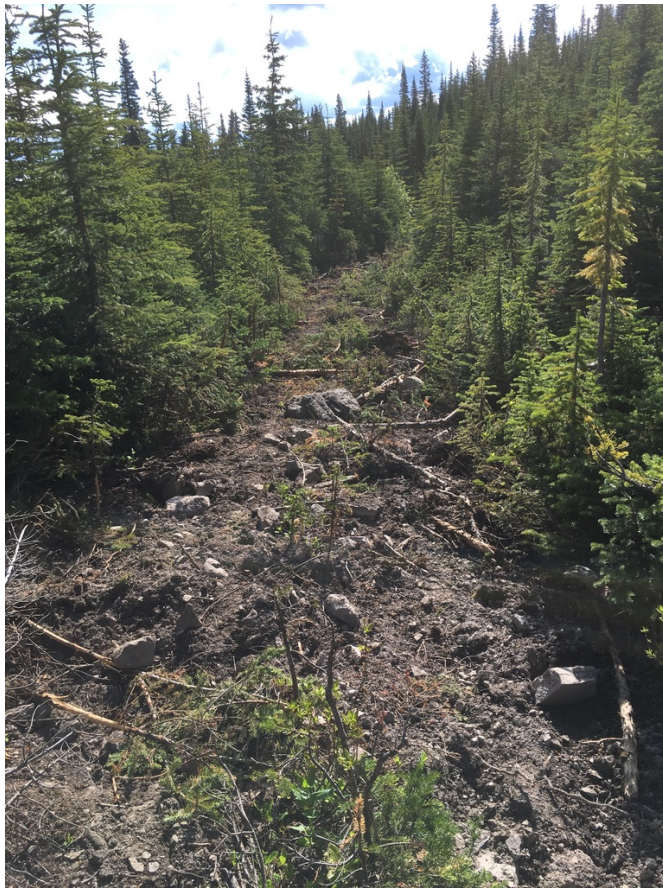
Photo 9: Machine screening on Line Segment #26.

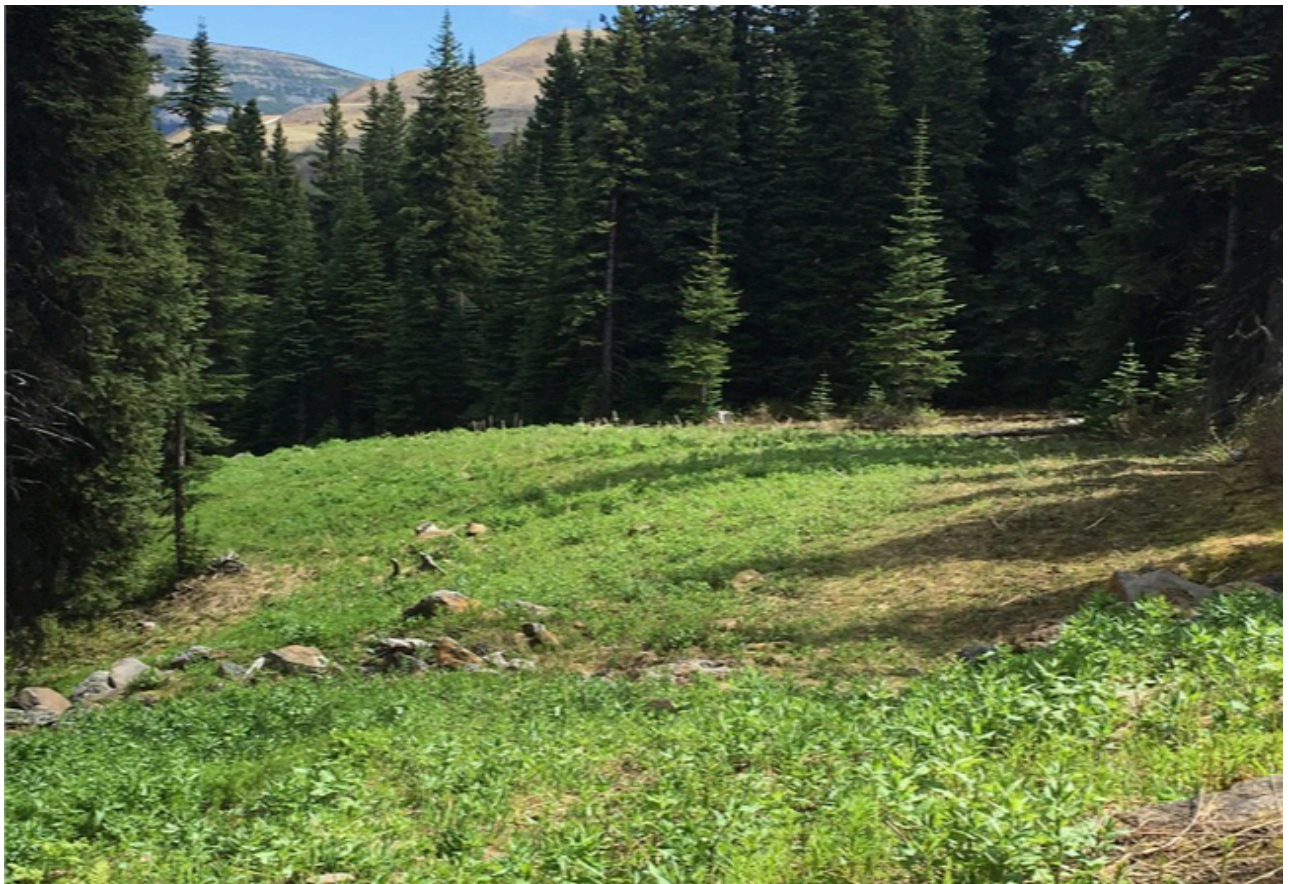
Photo 10: Line Segment #23 which was used as the overflow for the project seedlings and planted.

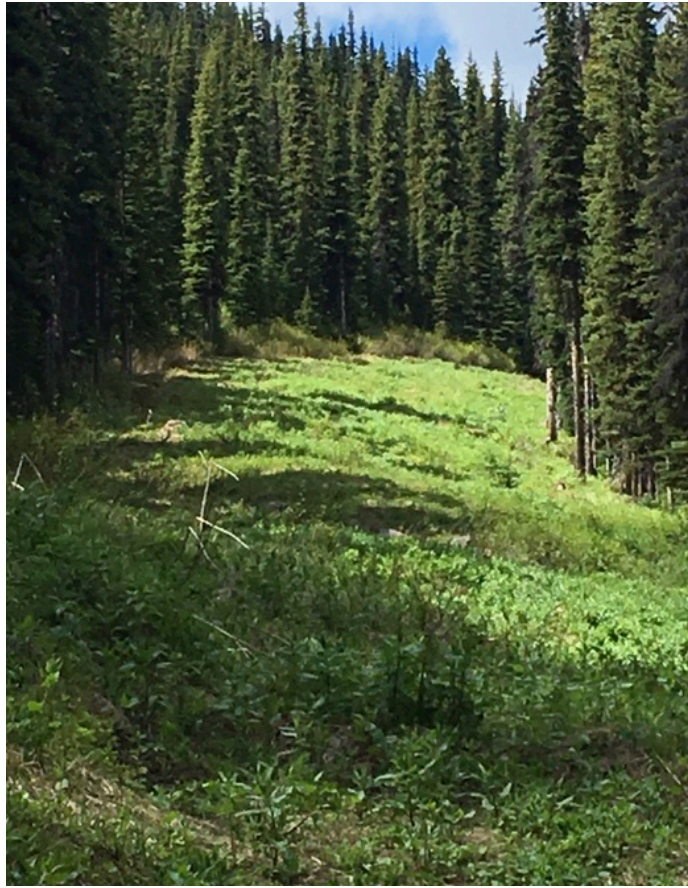
Photo 11: Line Segment #15 which was planted as the overflow for the project seedlings.

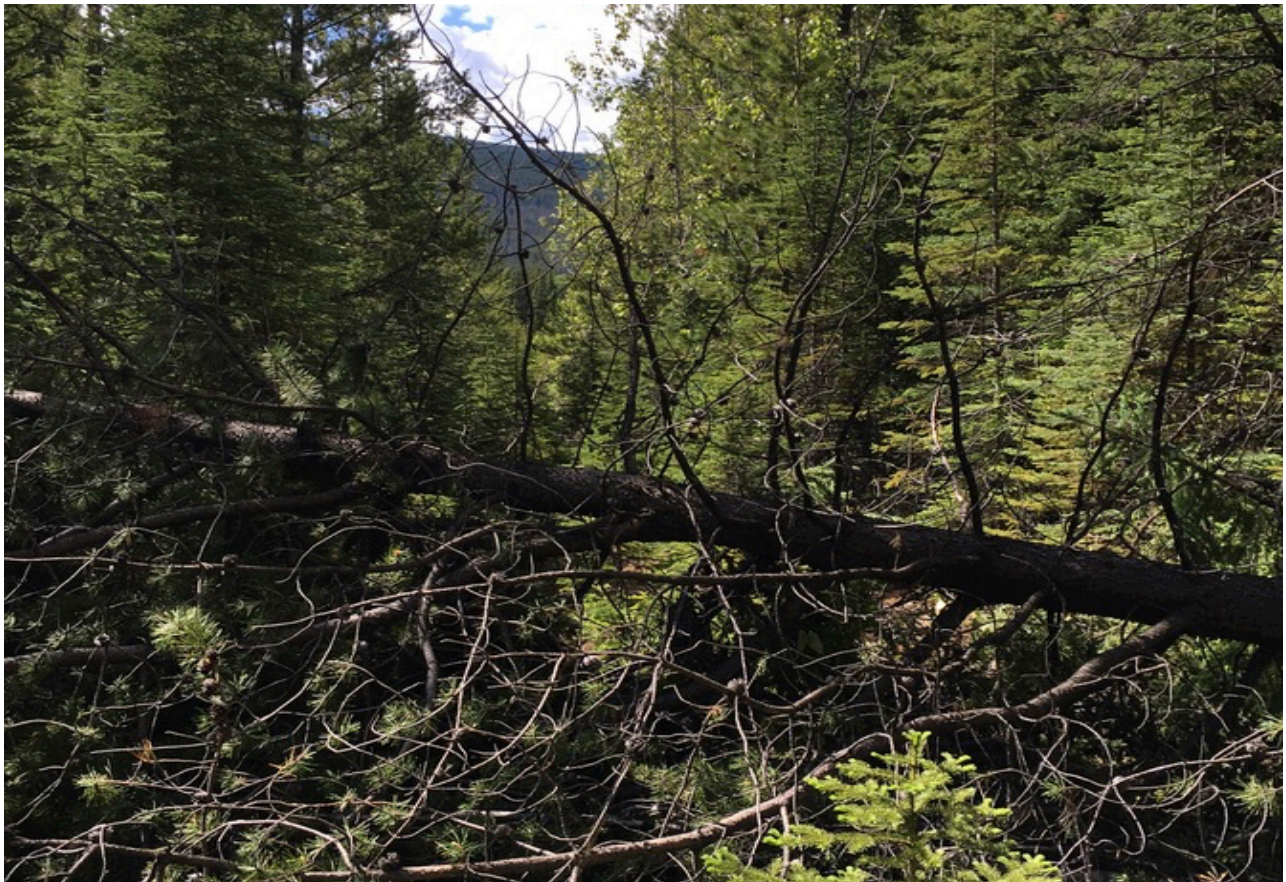
Photo 12: Typical tree-felling on lowland Line Segment #93 near the Bullmoose Rd.

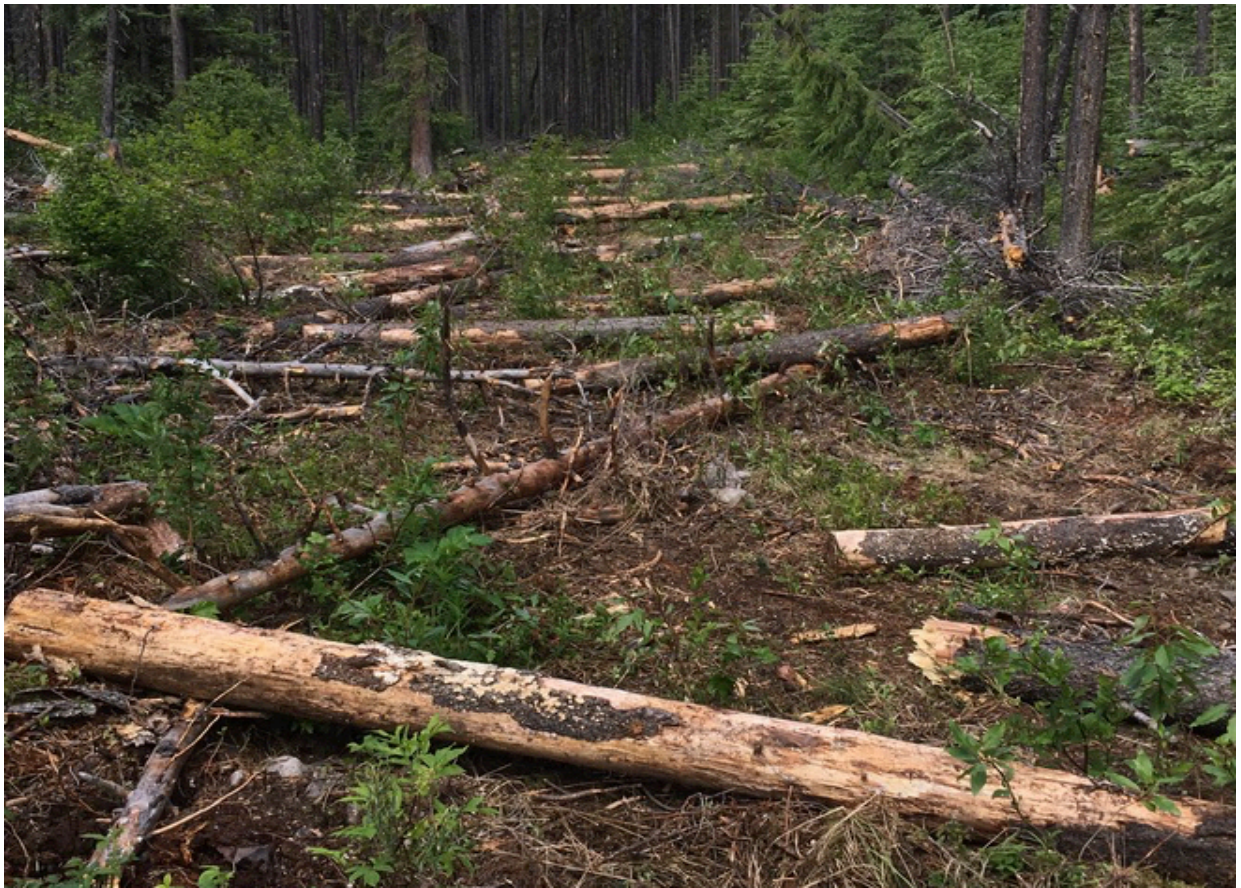
Photo 13: Machine screefing and debris rollback on Line Segment #74.

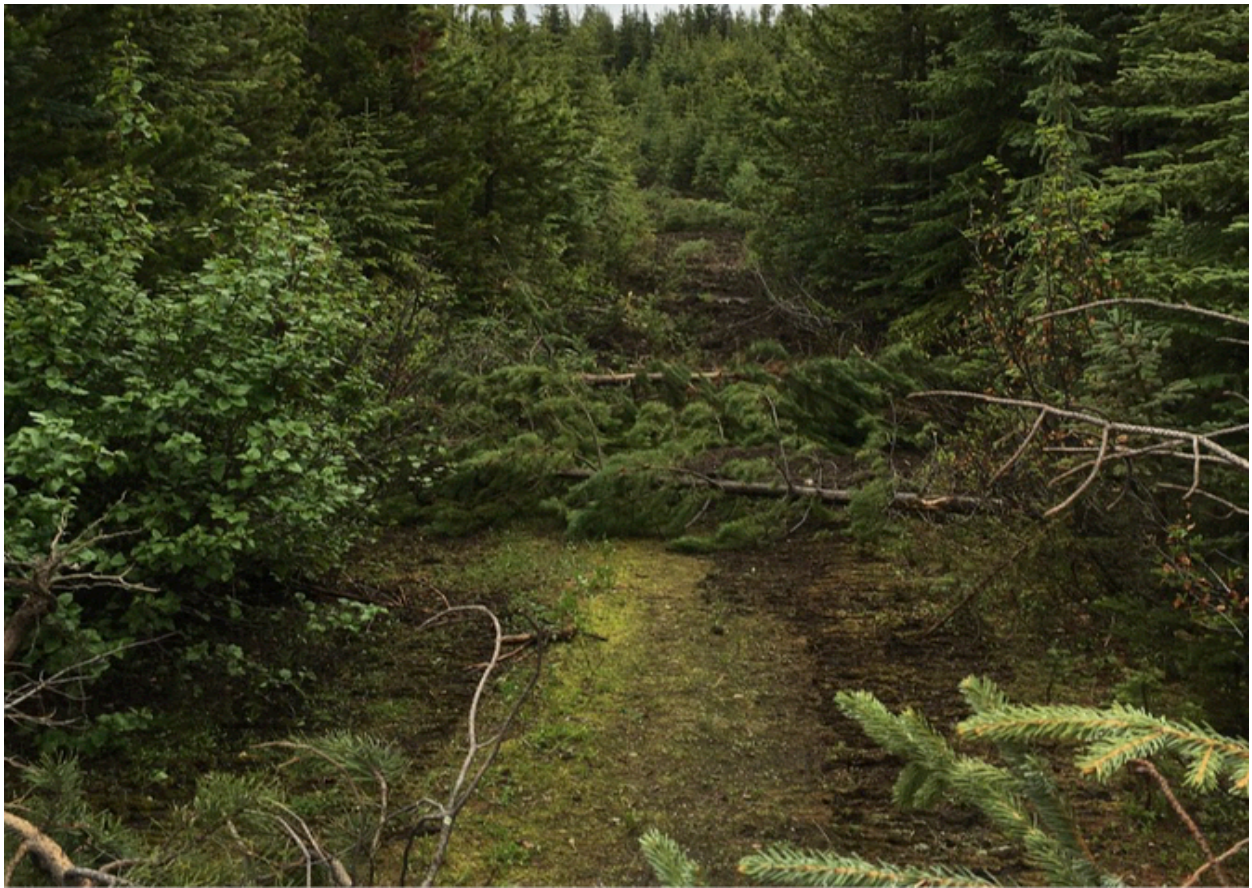
Photo 15: Tree felling treatment in immature timber type on Line Segment #75.

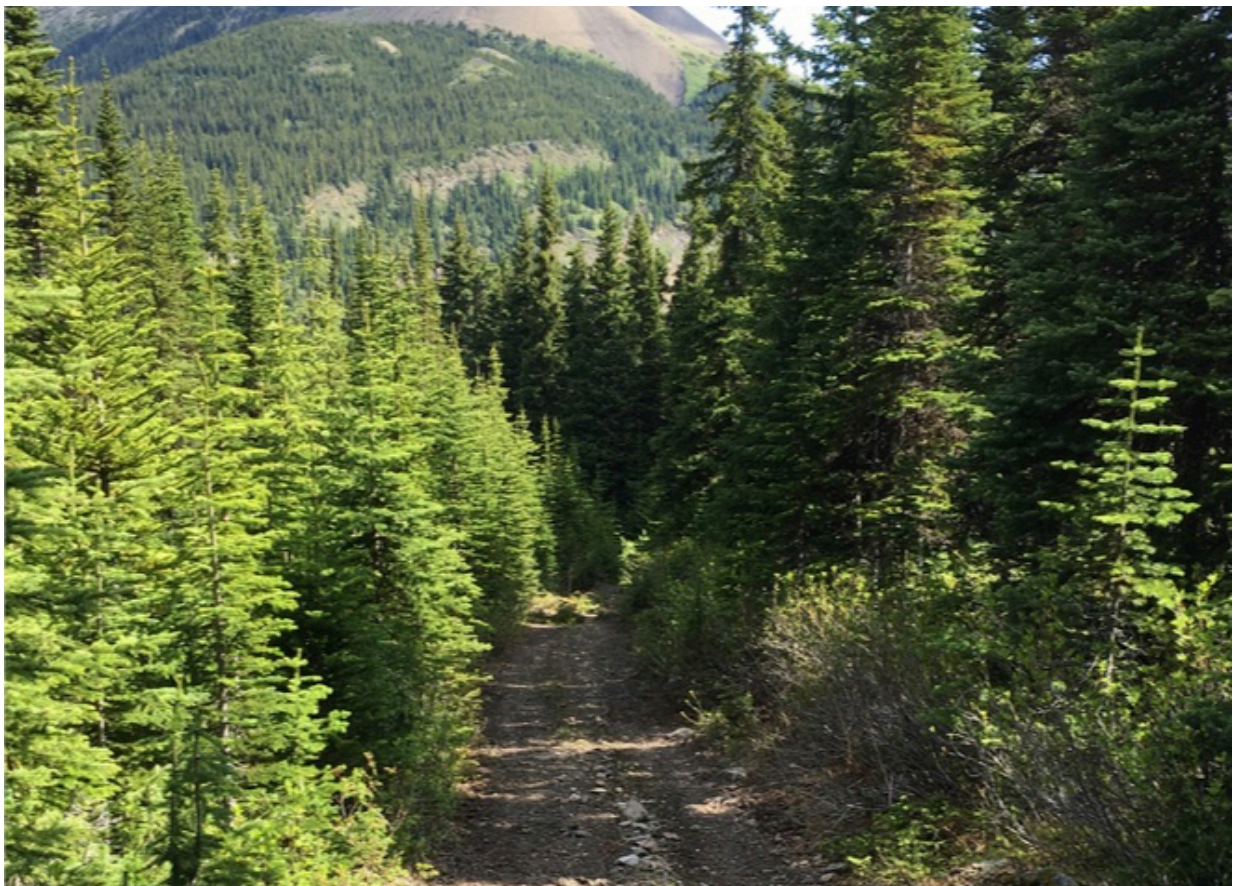
Photo 16: Disturbance feature near Line Segment #34 looking north towards Bullmoose Mountain.

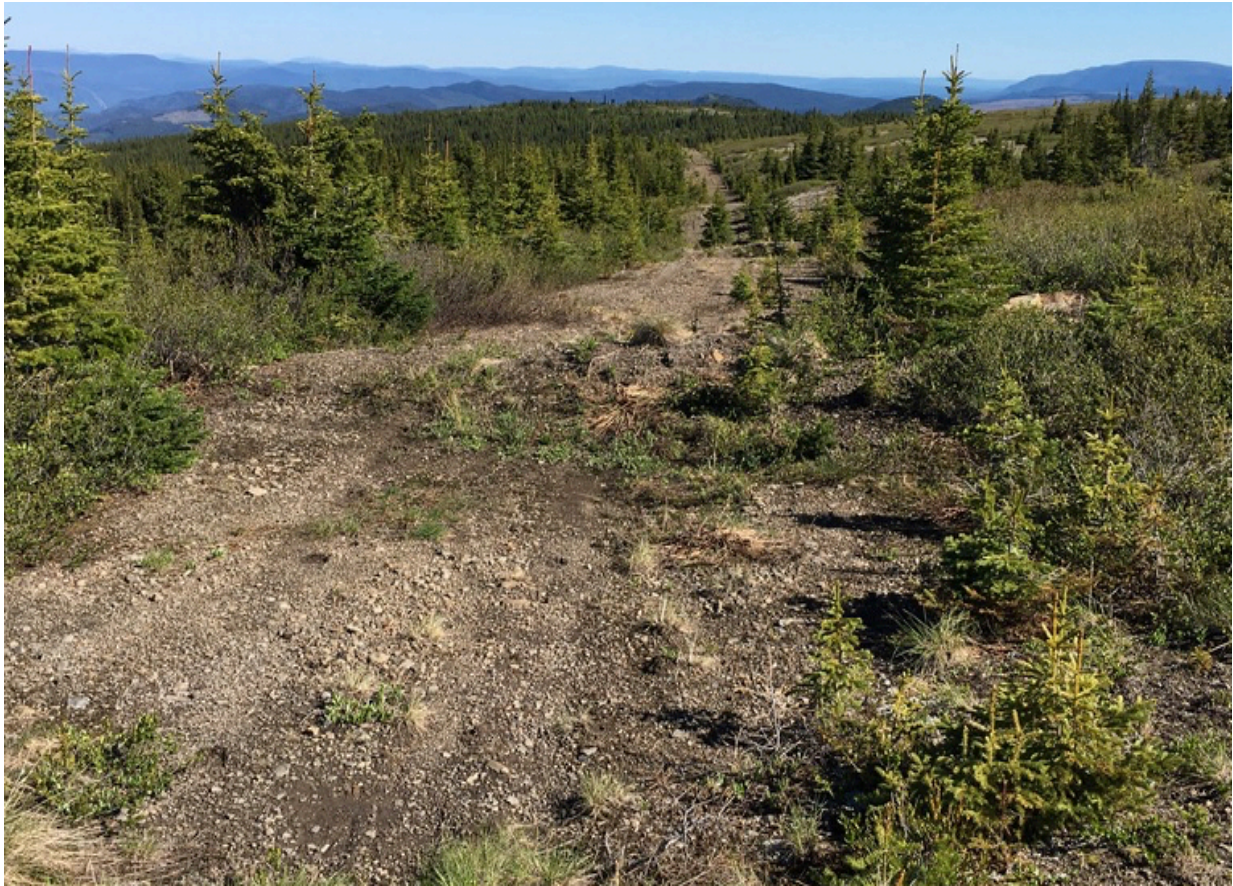
Photo 17: Disturbance feature, looking east, in subalpine-alpine environment located west of Bullmoose Mountain.

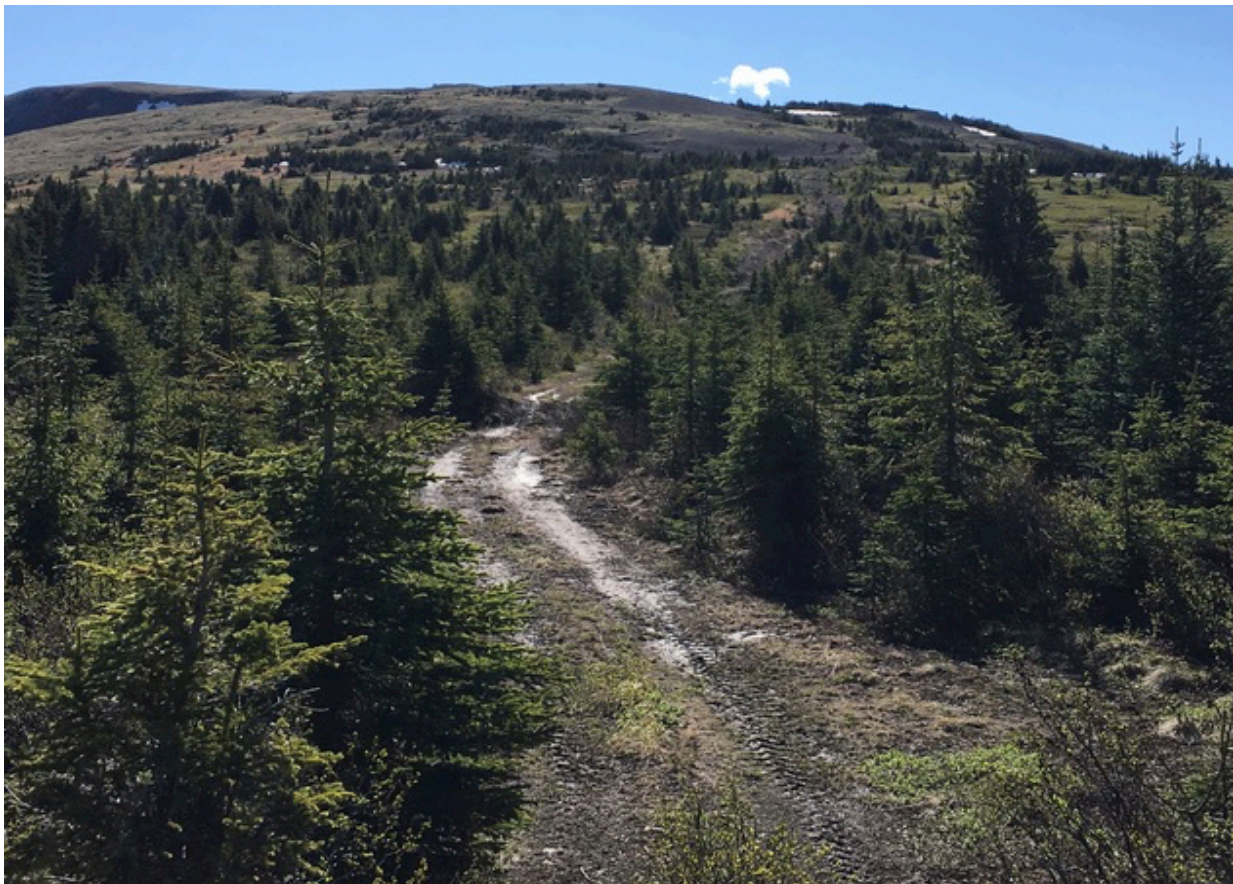
Photo 18: Disturbance feature, looking south, in subalpine-alpine environment located west of Bullmoose Mountain.
