# Whitesail Reach Caribou Calving Islands Rehabilitation Project Plan and Site Prescriptions

Date: 21.03.2019 | DWB file: 19447-043 | Revisions: Draft

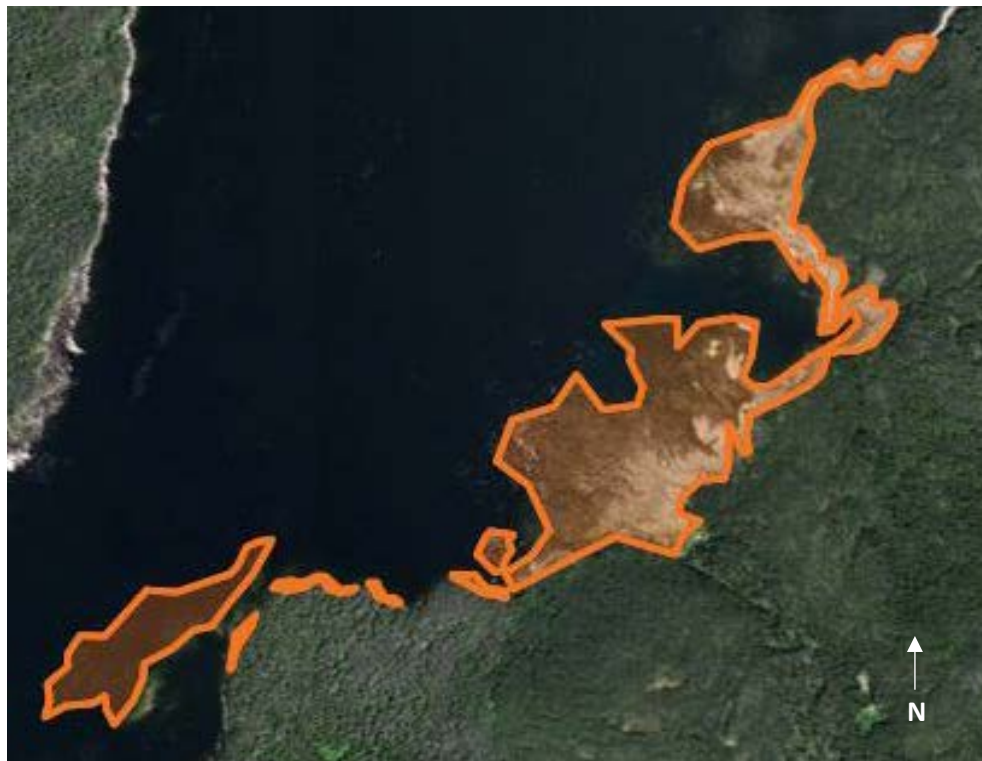
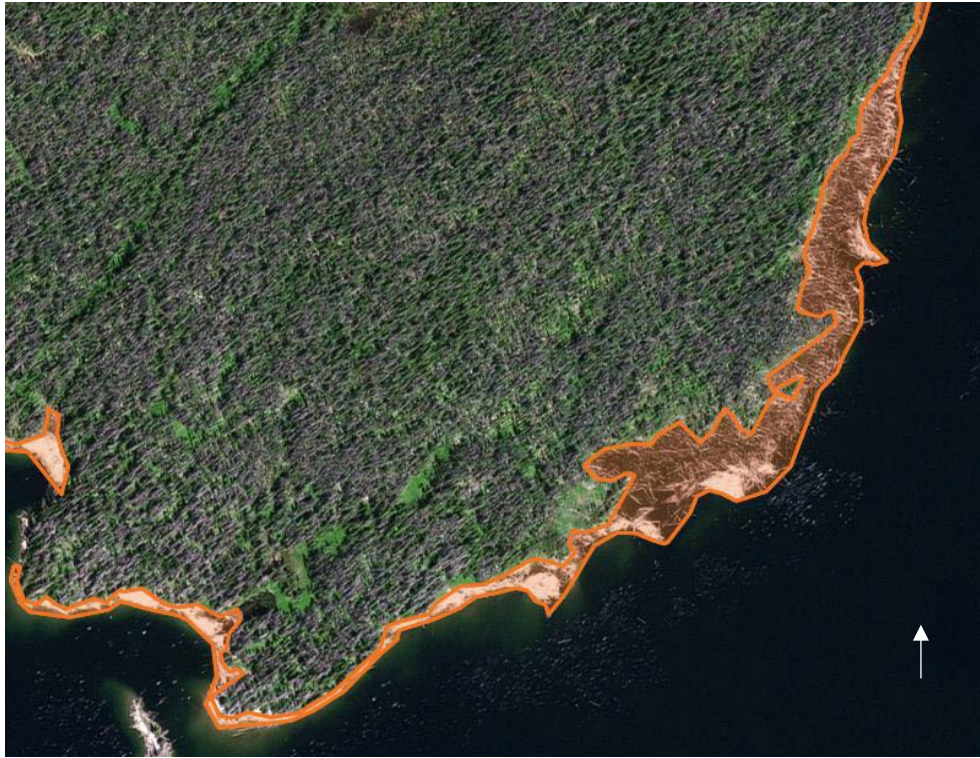
**Figure 4. Aerial photographs showing a) the western shoreline of Tweedsmuir Provincial Park adjacent to the island and b) the south eastern portion of Porcupine Island. Woody debris management areas are highlighted in orange.**

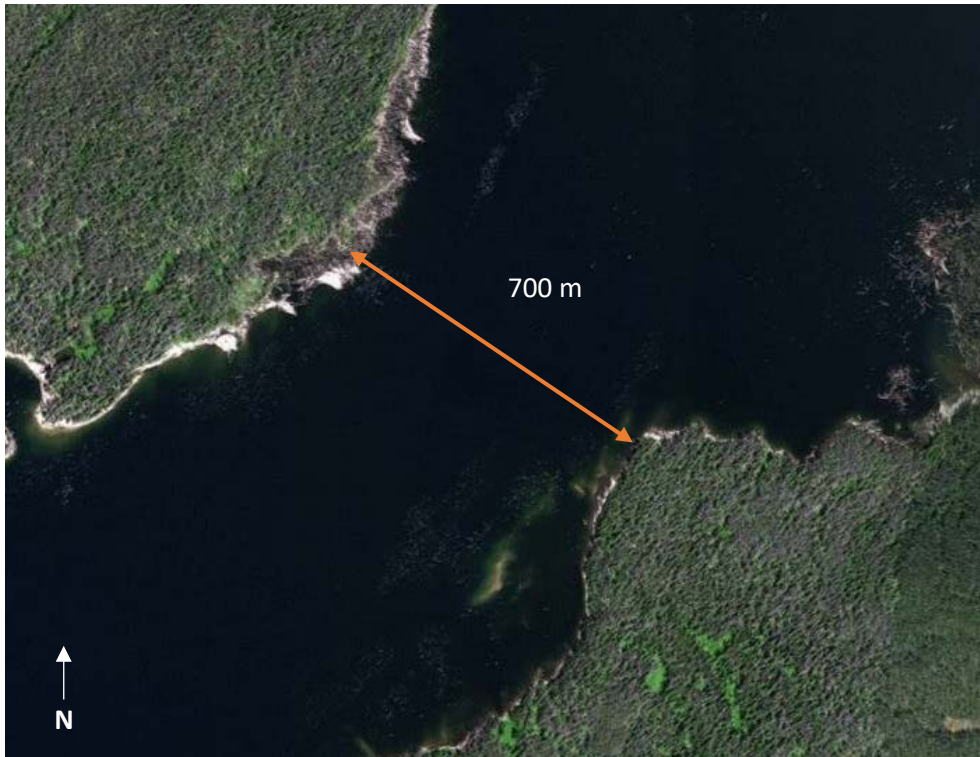
**Figure 5. Aerial photograph showing the shortest distance between Porcupine Island and the mainland along the western portion of Tweedsmuir Provincial Park.**

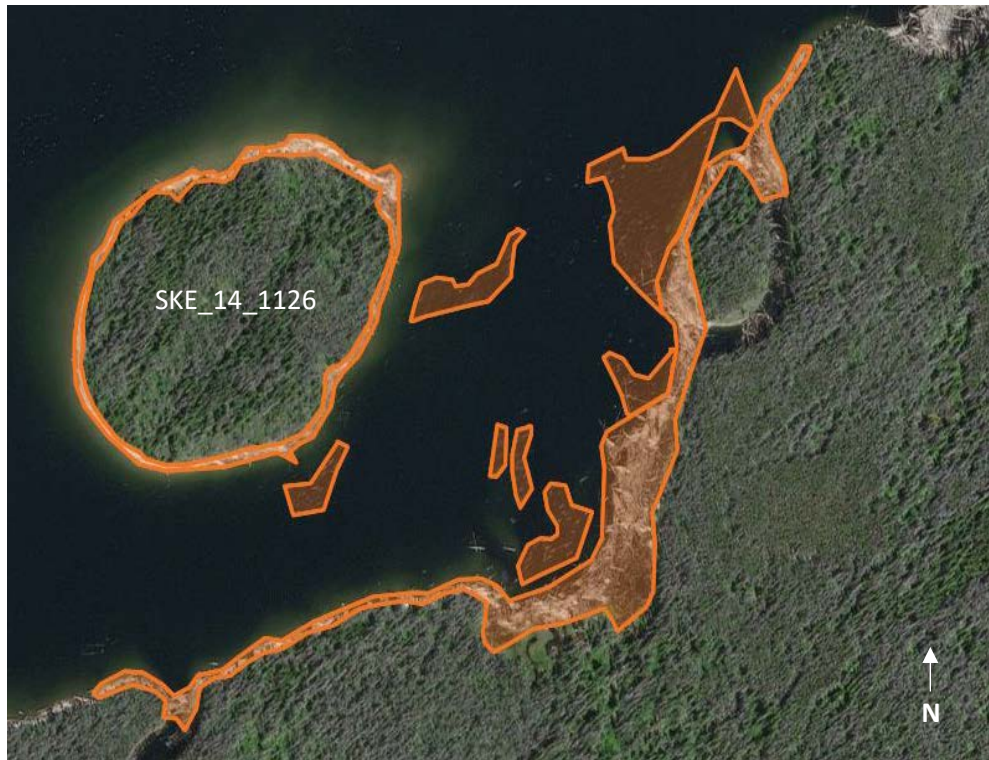
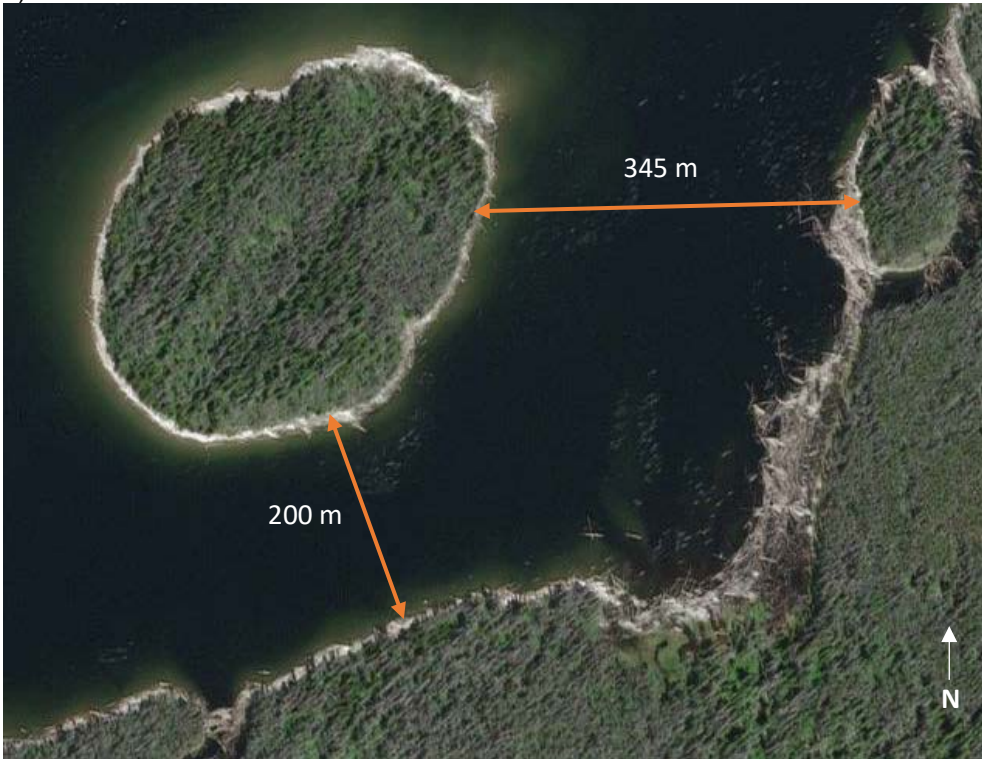
Figure 6. Orthophoto showing a) woody debris management areas on the island and mainland highlighted in orange, and b) the shortest distances between the island and the western shore of Tweedsmuir Provincial Park.

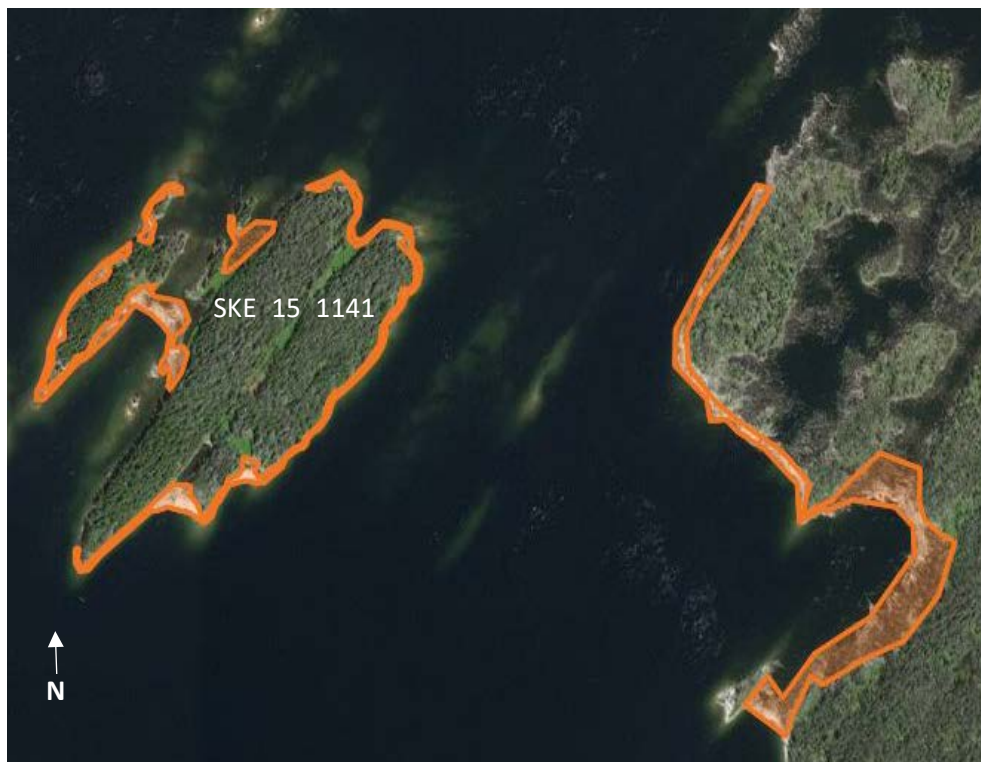
Figure 7. Orthophoto of the SKE\_15\_1141 island group. Debris management activities are planned to be completed along the shoreline of the island and the mainland; woody debris management areas are highlighted in orange.

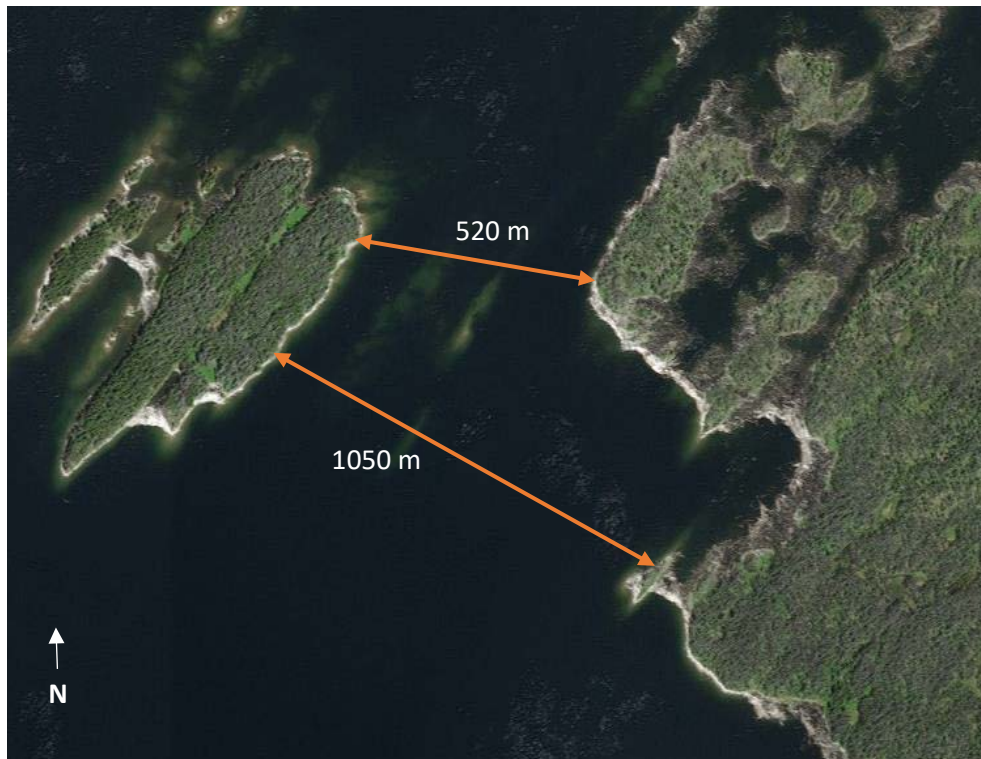
Figure 8. Orthophoto showing the shortest distance between the Island group and the mainland along the western portion of Tweedsmuir Provincial Park.

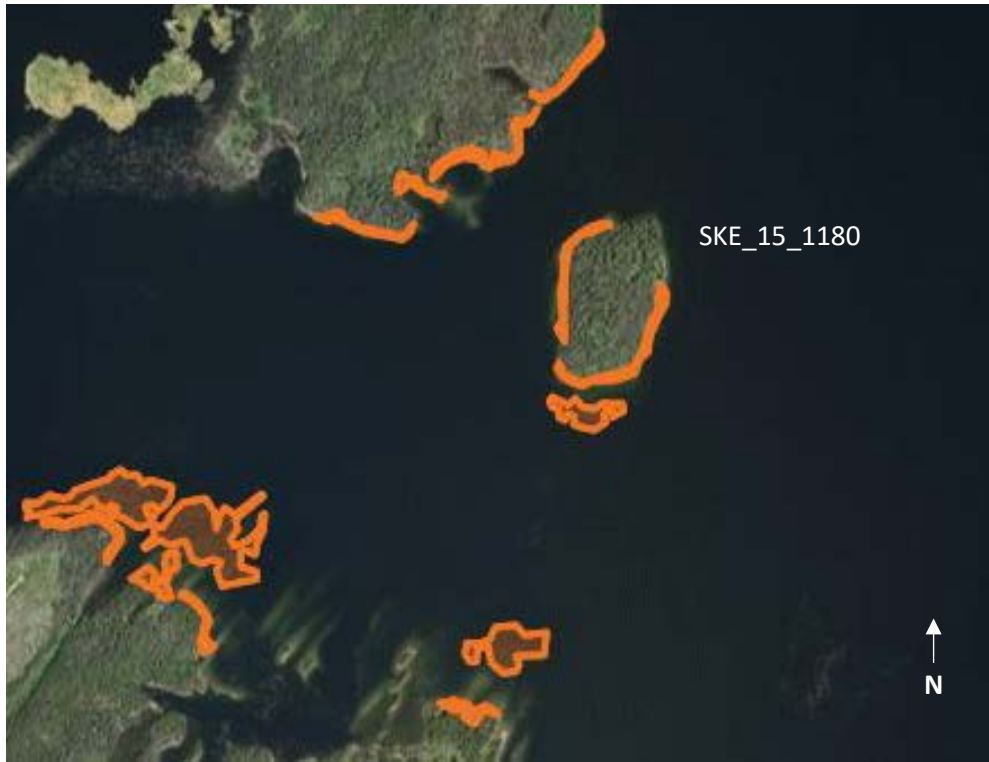
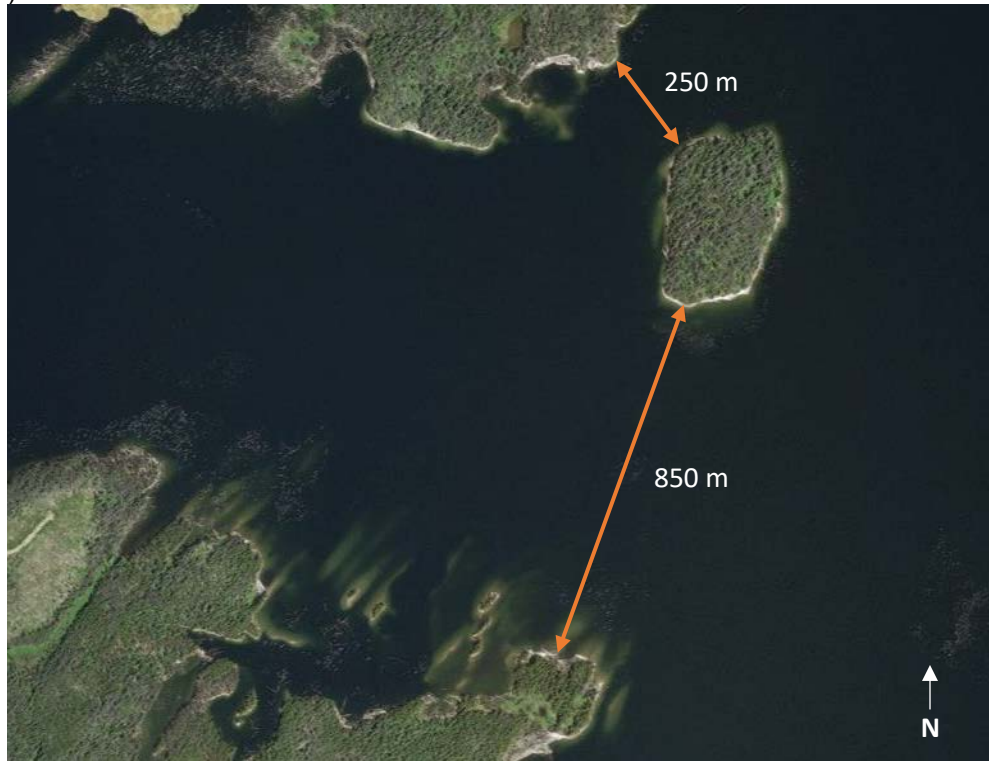
**Figure 9. Aerial photographs showing a) where debris management activities are planned to be completed along the shoreline of the island and the mainland (highlighted in orange) and b) the shortest distance between the island the western shoreline of Whitesail Reach and between the two islands.**

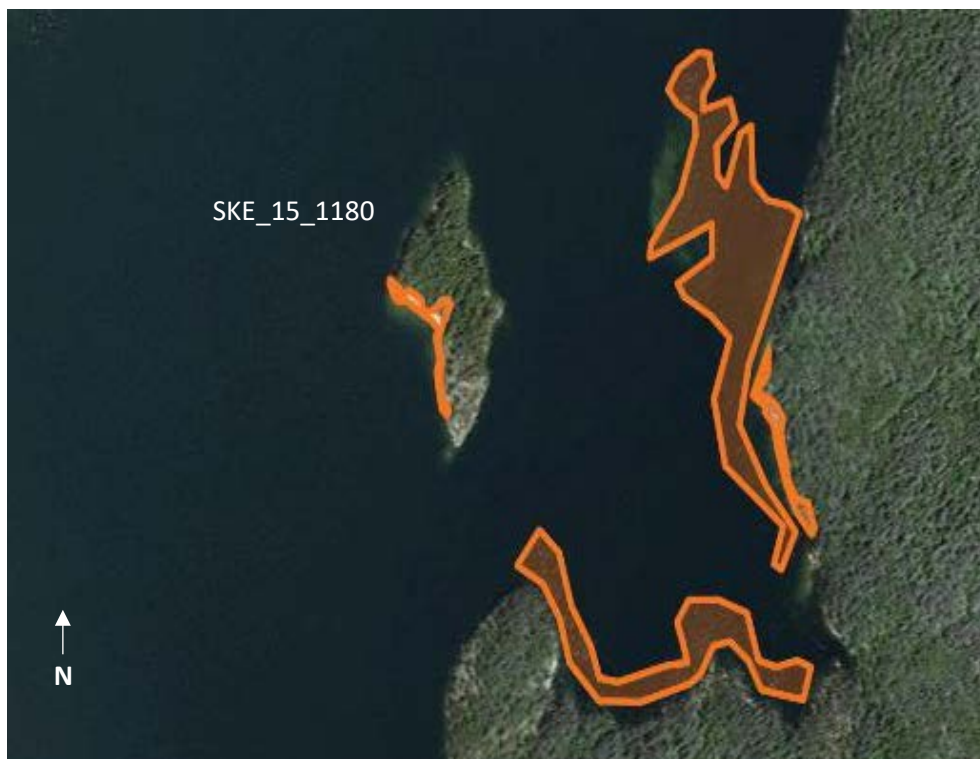
**Figure 10. Aerial photograph of the SKE\_15\_1180. Debris management activities are planned to be completed along the shoreline of the island and the mainland; woody debris management areas are highlighted in orange.**

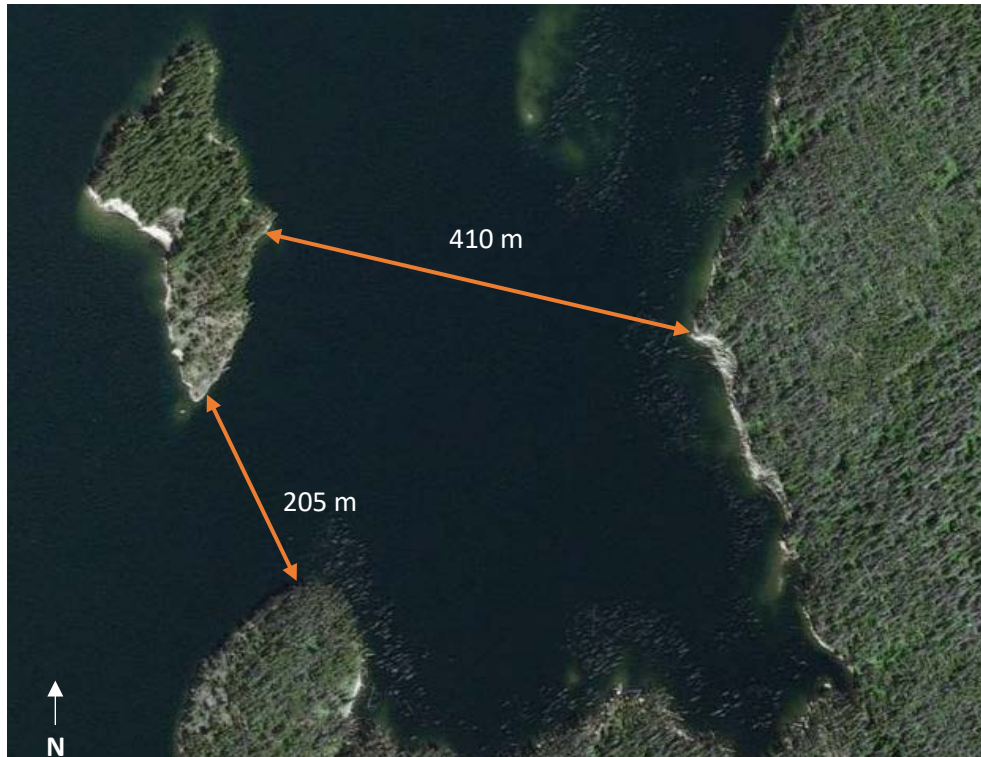
Figure 11. Aerial photograph showing the shortest distance between the Island group and the mainland along the western portion of Tweedsmuir Provincial Park.
