SOCIETY FOR ECOSYSTEM RESTORATION  
IN NORTHERN BRITISH COLUMBIA

## **Bulkley River and Morice River Watershed Groups Fish Passage Restoration Planning 2021**

**Prepared for  
Habitat Conservation Trust Foundation - CAT21-6-288  
BC Fish Passage Remediation Program  
Canadian Wildlife Federation**

**Prepared by  
Al Irvine, B.Sc., R.P.Bio.  
New Graph Environment Ltd.  
on behalf of  
Society for Ecosystem Restoration in Northern British Columbia**

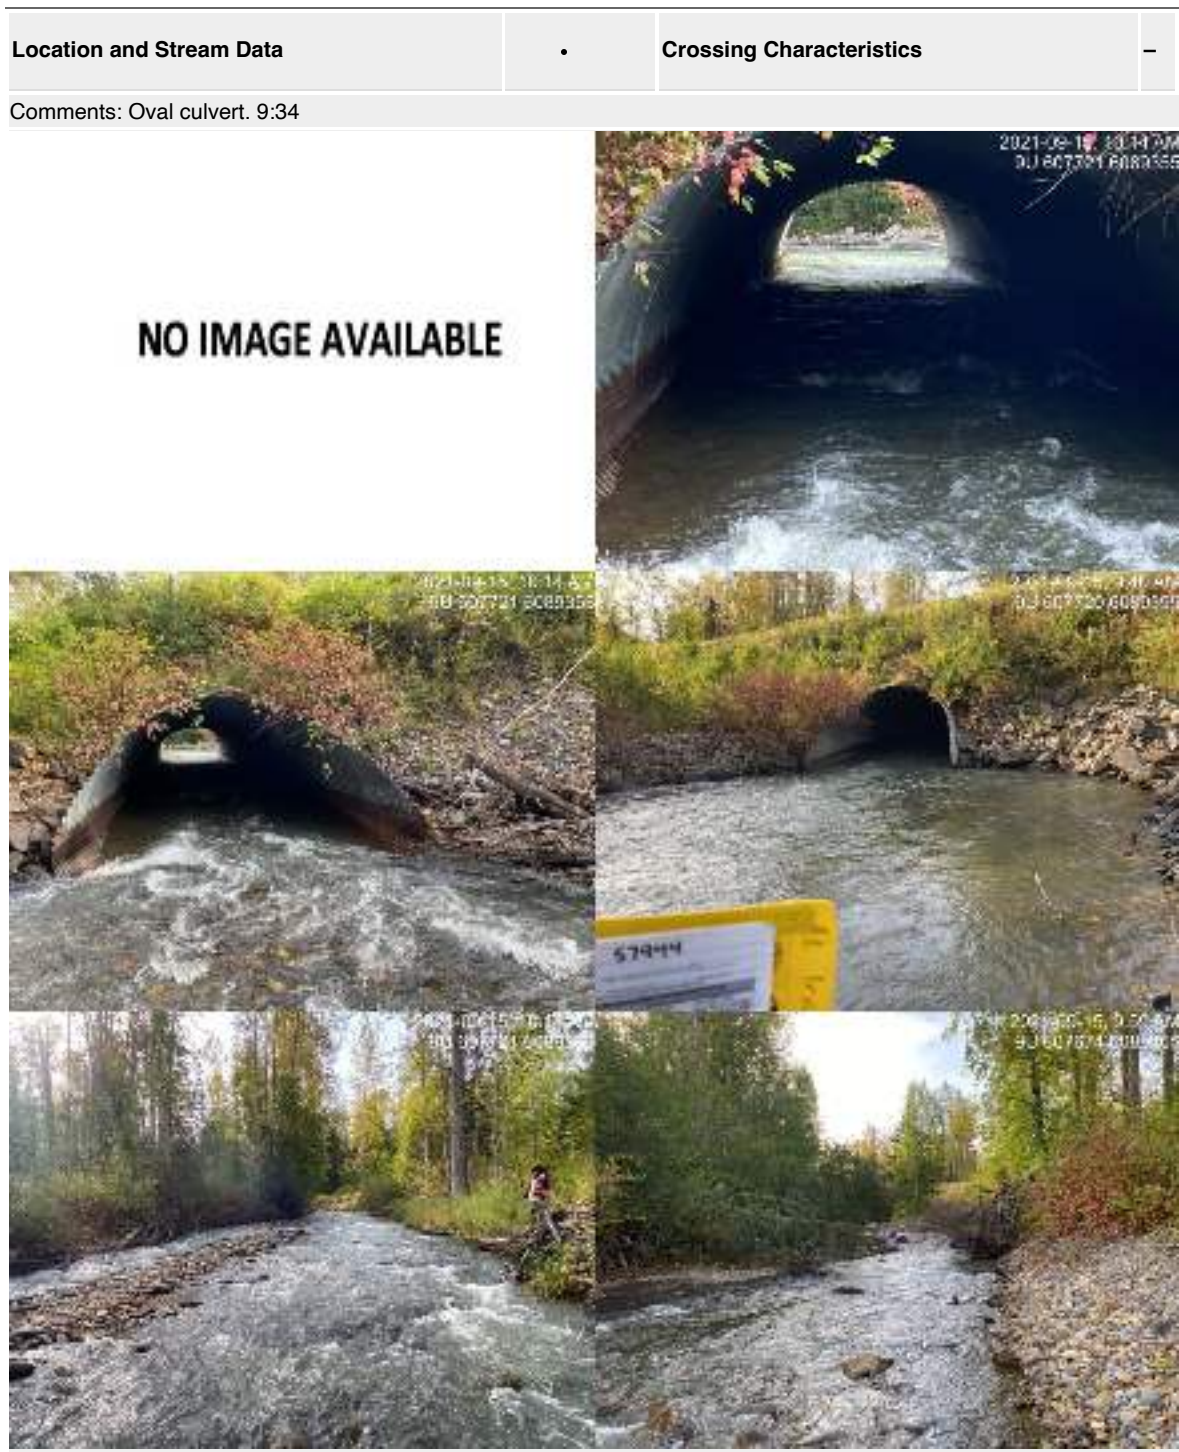
| Location and Stream Data | | Crossing Characteristics | |
|---|--|---|---|
| Photos: From top left clockwise: Road/Site Card, Barrel, Outlet, Downstream, Upstream, Inlet. | | | |

| Location and Stream Data | | Crossing Characteristics | |
|---|--|---|---|
| Fix type | Replace with New Open Bottom Structure | Fix Span / Diameter | 13.5 |

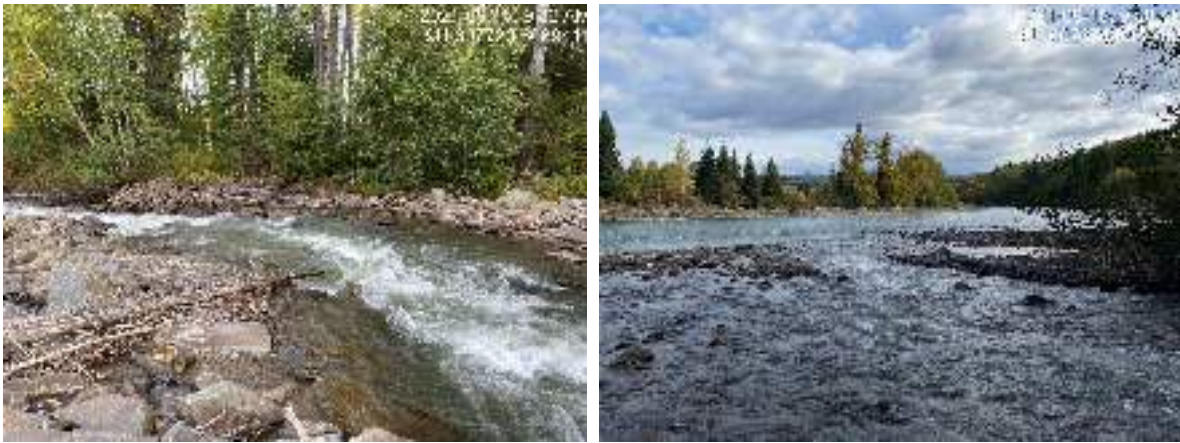
The stream was surveyed downstream from crossing 57944 for 140m to the confluence with the Bulkley River (Figure 5.1). Total cover amount was rated as moderate with undercut banks dominant. Cover was also present as small woody debris, large woody debris, boulders, and

Figure 5.1: Left: Typical habitat downstream of PSCIS crossing 57944. Right: Typical habitat downstream of PSCIS crossing 57944.

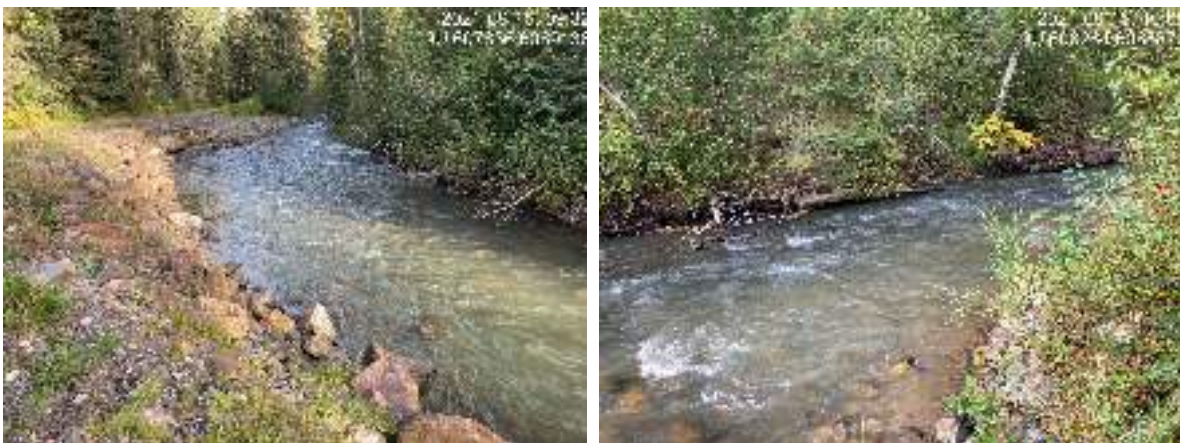
The stream was surveyed upstream from crossing 57944 for 880m (Figure 5.2). Total cover amount was rated as moderate with large woody debris dominant. Cover was also present as small woody debris and boulders. Total cover amount was rated as moderate with overhanging vegetation dominant. Cover was also present as small woody debris and boulders. The average channel width was 8.5m, the average wetted width was 6.7m and the average gradient was 2.1%. The dominant substrate was cobbles with gravels subdominant. The first 50 - 100m upstream of crossing channel and banks were noted as armoured with riprap. Abundant gravels suitable for resident and anadromous salmonids were noted throughout. The habitat was rated as high value as an important migration corridor containing suitable spawning habitat and having moderate rearing potential.

Figure 5.2: Left: Typical habitat upstream of PSCIS crossing 57944. Right: Typical habitat upstream of PSCIS crossing 57944.

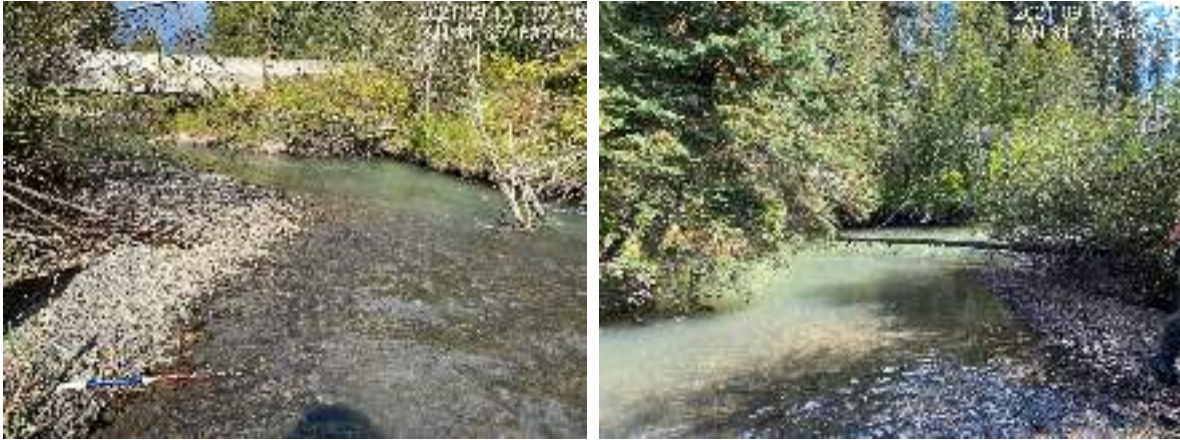
The stream was also surveyed at a second location upstream of the hatchery adjacent to the Owen Road bridge for 150m (Figure 5.3). Total cover amount was rated as abundant with deep pools dominant. Cover was also present as small woody debris, undercut banks, and overhanging vegetation. The average channel width was 12.6m, the average wetted width was 10.5m and the average gradient was 0.5%. The dominant substrate was gravels with fines subdominant. The habitat was rated as high value for salmon rearing and spawning.

Figure 5.3: Left: Typical habitat upstream of PSCIS crossing 57944. Right: Typical habitat upstream of PSCIS crossing 57944.

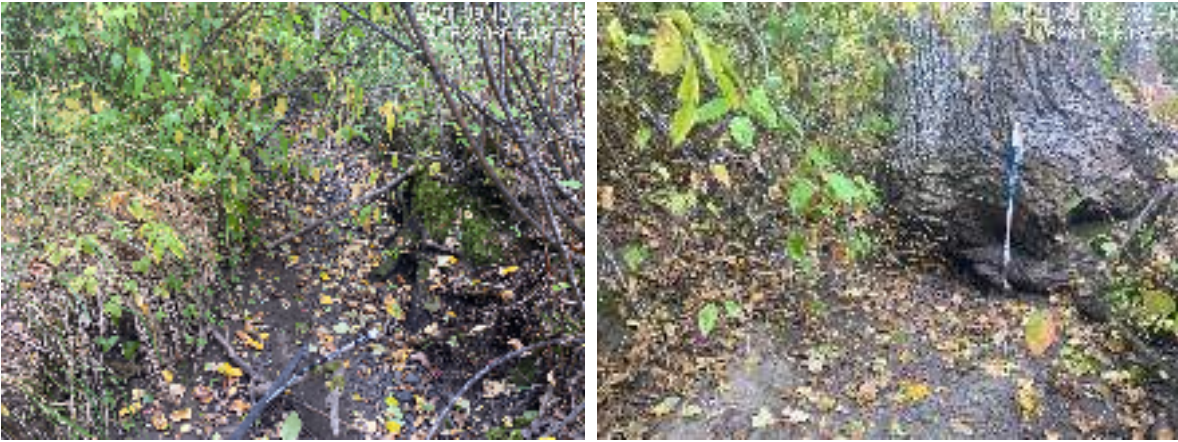
The stream was surveyed downstream from crossing 123544 for 300m (Figure 5.5). Total cover amount was rated as abundant with undercut banks dominant. Cover was also present as small

Figure 5.5: Left: Habitat downstream of PSCIS crossing 123544. Right: Habitat downstream of PSCIS crossing 123544.

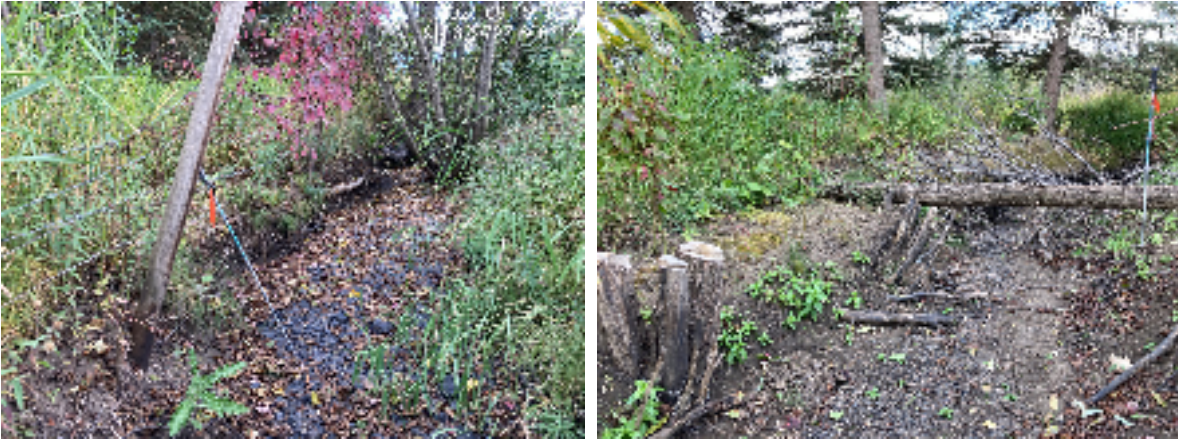
The stream was surveyed upstream of crossing 123544 for 25m and downstream from crossing 58151 for 120m (Figure 5.6). The average channel width was 1.7m, and the average gradient was 2%. The dominant substrate was fines with gravels sub-dominant. Total cover amount was rated as abundant with overhanging vegetation dominant. Cover was also present as small woody debris and undercut banks. With the exception of the culvert outlet pool, the channel was dry throughout the area surveyed. Riparian vegetation was primarily grass. Habitat value was rated as low as the surveyed area was dry with extensive agricultural development adjacent.

Figure 5.6: Left: Habitat downstream of PSCIS crossing 58151. Right: Typical habitat upstream of PSCIS crossing 123544.

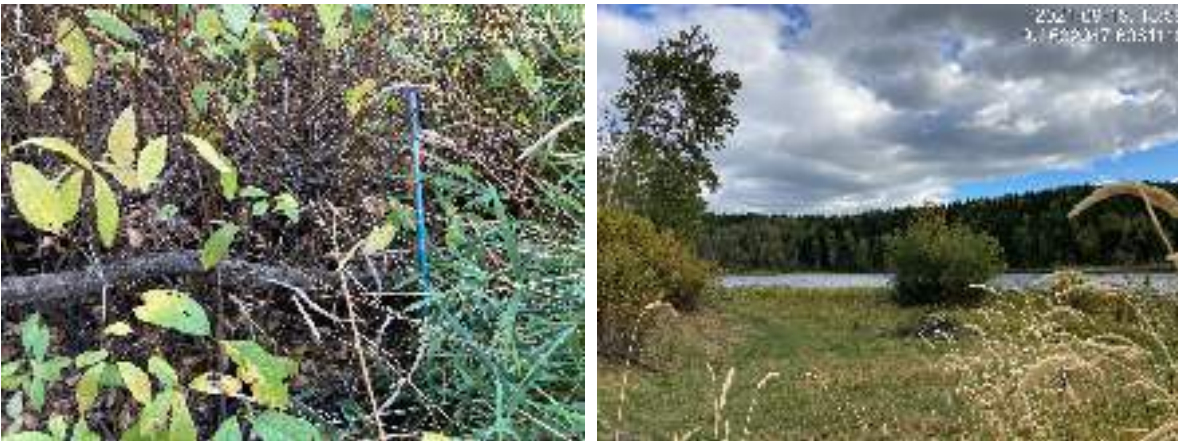
The stream was surveyed upstream from crossing 58151 for 70m (Figure 5.7). The average channel width was 1.7m, and the average gradient was 2%. Total cover amount was rated as abundant with overhanging vegetation dominant. Cover was also present as small woody debris and undercut banks. The dominant substrate was fines with gravels sub-dominant. Survey notes indicate the well defined channel bed was dry and contained fines and sediment likely from the high amount of development of yards, roads, and agriculture adjacent to the stream. Habitat value was rated as low.

Figure 5.7: Left: Typical habitat upstream of PSCIS crossing 58151. Right: Typical habitat upstream of PSCIS crossing 58151.

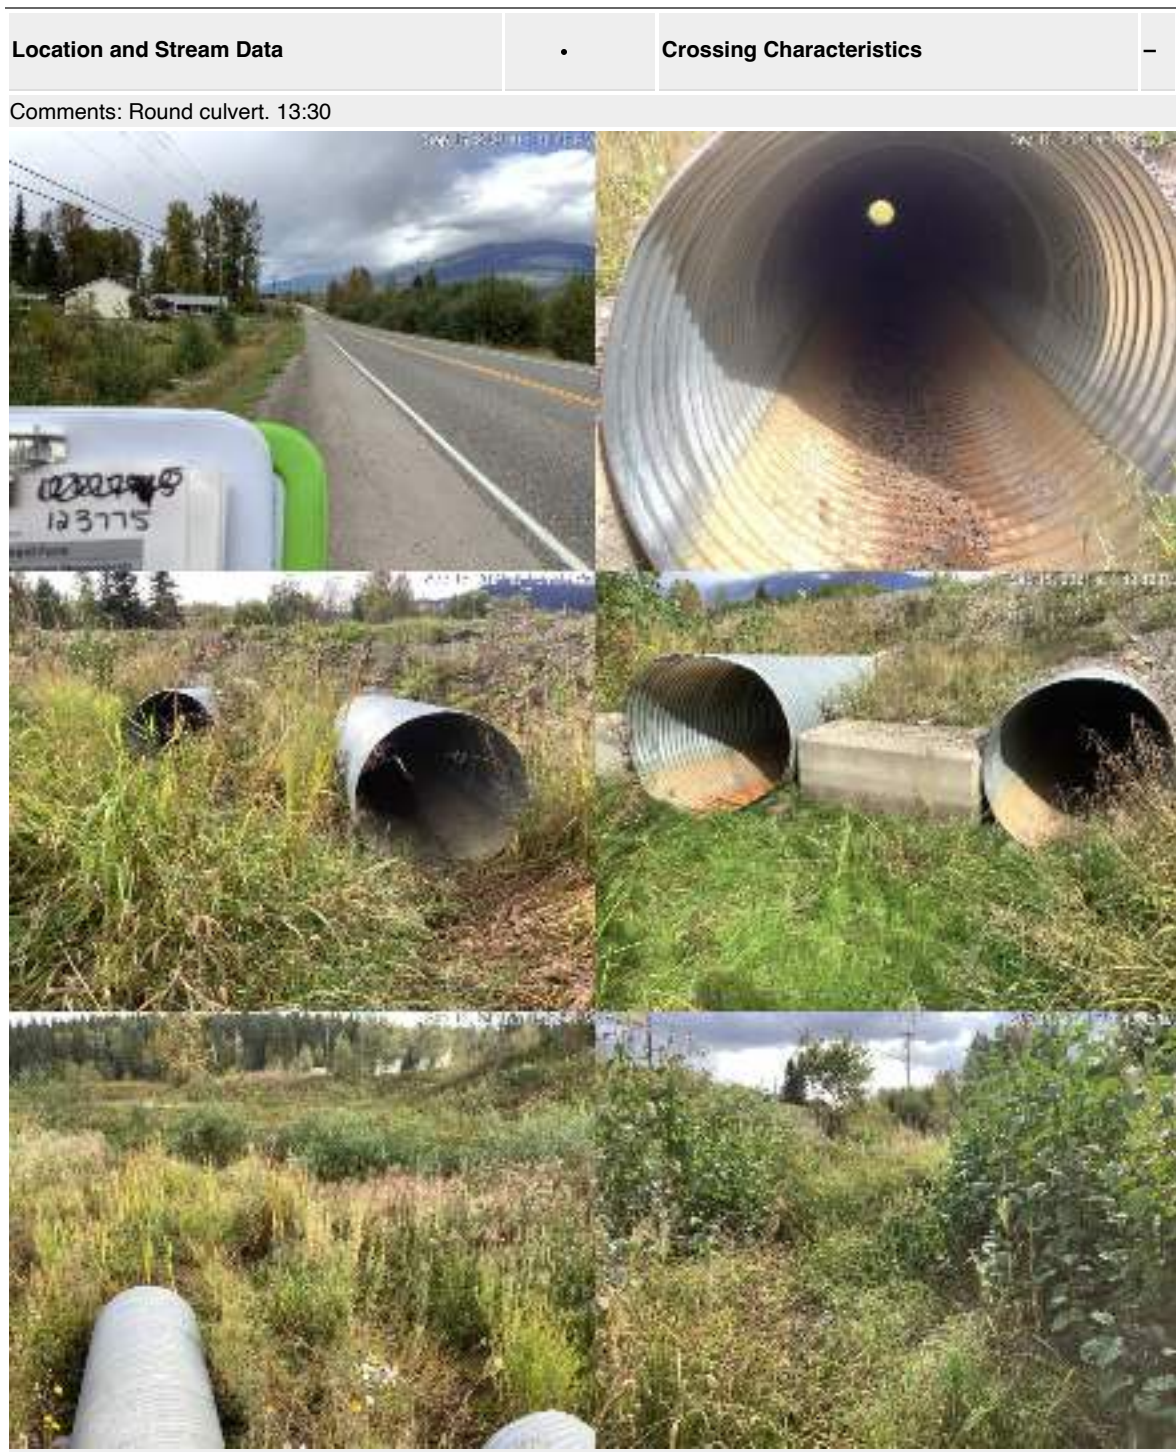
Photos: From top left clockwise: Road/Site Card, Barrel, Outlet, Downstream, Upstream, Inlet.

| Location and Stream Data | . | Crossing Characteristics | - |
|---|---|---|---|
| Fix type | Replace Structure with Streambed Simulation CBS | Fix Span / Diameter | 3 |

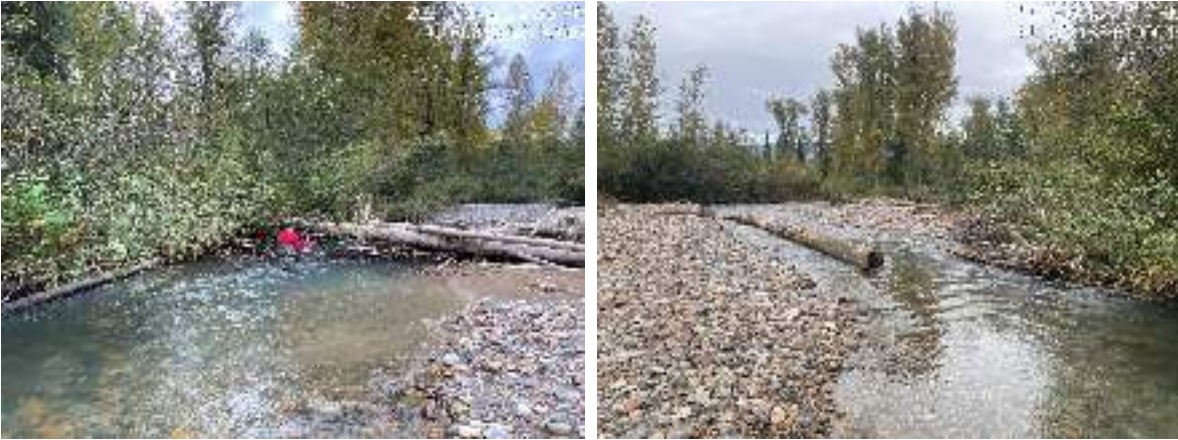
The stream was surveyed downstream from crossing 197960 for 450m (Figure 5.27). Total cover amount was rated as moderate with overhanging vegetation dominant. Cover was also present as small woody debris, large woody debris, undercut banks, and deep pools. The average channel

Figure 5.27: Left: Typical habitat downstream of PSCIS crossing 197960. Right: Typical habitat downstream of PSCIS crossing 197960.

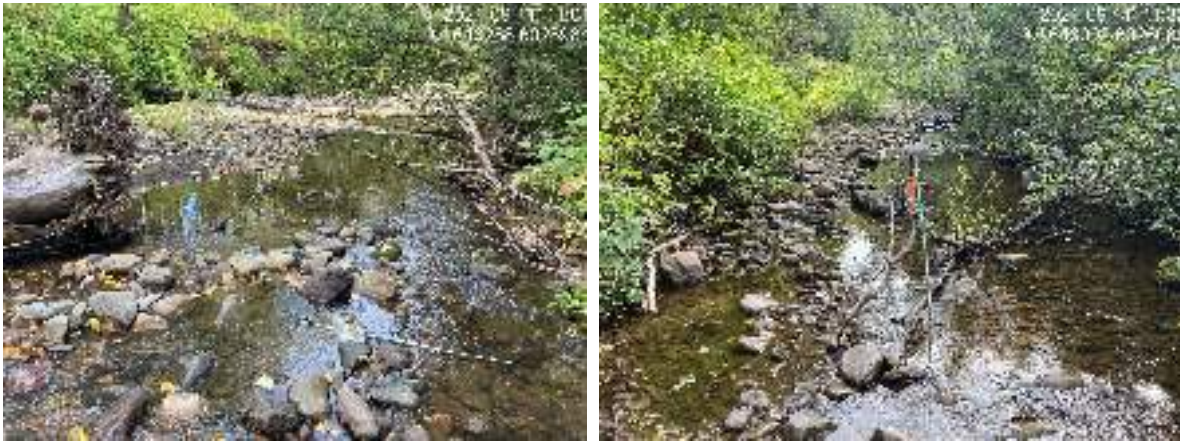
The stream was surveyed downstream from crossing 197962 for 600m (Figure 5.30). The dominant substrate was cobbles with boulders sub-dominant., The average channel width was 8.1m, the

average wetted width was 4.2m, and the average gradient was 2.6%. Total cover amount was rated as moderate with undercut banks dominant. Cover was also present as small woody debris, large woody debris, boulders, deep pools, and overhanging vegetation. Multiple areas of side channels and small braided sections were noted with intermittent sections of aggraded cobbles / gravels moved in high flows. There were pockets of gravel present suitable for spawning resident and anadromous salmonids.

Figure 5.30: Left: Habitat downstream of PSCIS crossing 197962. Right: Habitat downstream of PSCIS crossing 197962.

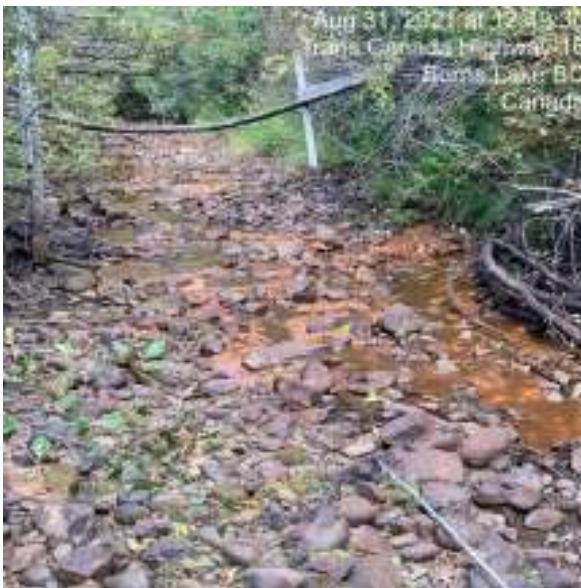
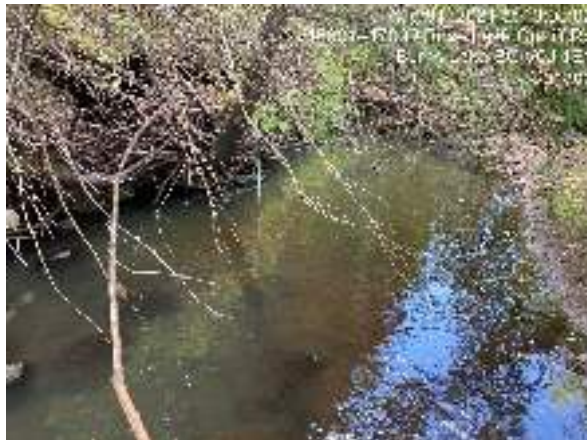
The stream was surveyed downstream from crossing 197967 for 375m to the bridge (PSCIS 197966) located on Ross Lake Cutoff Rd (Figure 5.32). The average channel width was 5.7m, the

average wetted width was 3.1m, and the average gradient was 2.5%. The dominant substrate was cobbles with fines sub-dominant. Total cover amount was rated as trace with overhanging vegetation dominant. Cover was also present as deep pools and instream vegetation. The site was noted as having significant amounts of thick red colored algae for the majority of survey. Flow was very low with uncommon pools. Fence material was noted in or across channel in two locations and riparian vegetation had been removed where an agricultural field and fence line were close. Although considered an important migration corridor, the habitat was rated as medium value for salmonid rearing and spawning due to limited complexity resulting from adjacent agricultural activities.

Figure 5.32: Left: Habitat downstream of PSCIS crossing 197967. Right: Habitat downstream of PSCIS crossing 197967.

Should restoration/maintenance activities proceed, replacement of PSCIS crossing 197967 with a bridge (31m span) is recommended. The cost of the work is estimated at \$18,600,000 for a cost benefit of 2.8 linear m/\$1000 and 14.8 m<sup>2</sup>/\$1000.

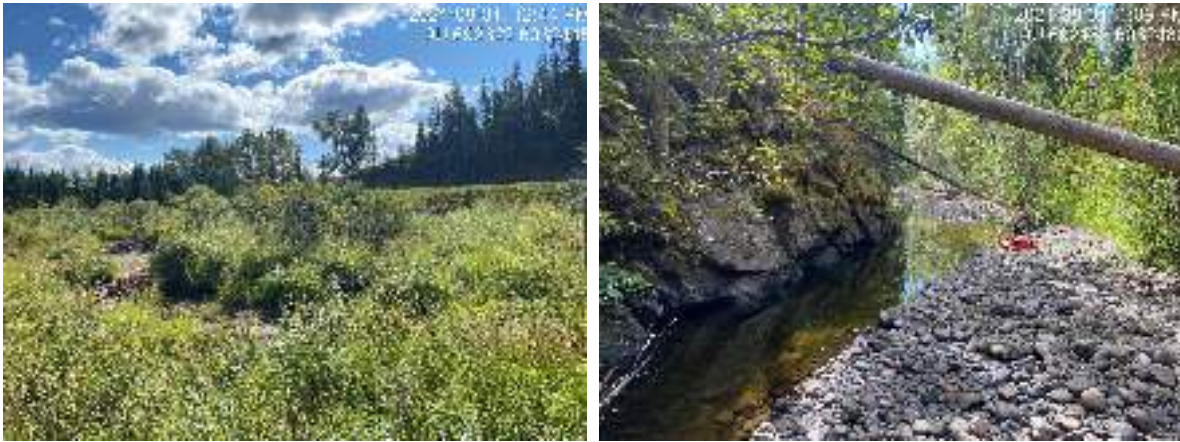
The stream was surveyed upstream from crossing 197967 for 800m (Figure 5.33). The average channel width was 5.3m, the average wetted width was 2.3m, and the average gradient was 2.5%.,

Total cover amount was rated as moderate with deep pools dominant. Cover was also present as large woody debris and overhanging vegetation., The dominant substrate was gravels with cobbles sub-dominant. The first ~250m of channel upstream of the highway were noted as beaver influenced wetland with extensive dry sections at the time of the survey. Frequent pockets of gravels and small cobbles suitable for rainbow trout and coho salmon spawning were noted throughout the area surveyed. A canyon section of stream was located upstream of the crossing approximately 300m contained deep bedrock pools with small fish present and no large woody debris. One deep pool upstream of the canyon section contained likely 2-3 year old juveniles (coloring indicated rainbow trout, unverified). The habitat was rated as medium value as an important migration corridor containing suitable spawning habitat and having moderate rearing potential.

Figure 5.33: Left: Habitat upstream of PSCIS crossing 197967. Right: Habitat upstream of PSCIS crossing 197967.

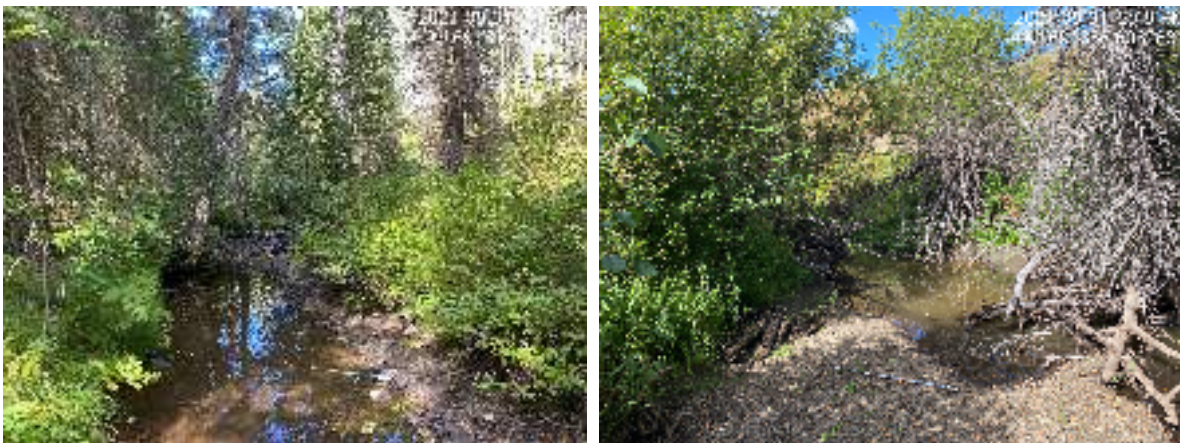
Taman Creek was surveyed for 400m above where it joins the Bulkley River mainstem upstream of PSCIS crossing 197967 (Figure [5.34](#)). Total cover amount was rated as moderate with deep pools dominant. Cover was also present as small woody debris, large woody debris, undercut banks, and overhanging vegetation., The average channel width was 3.8m, the average wetted width was 2.2m, and the average gradient was 2.5%., The dominant substrate was gravels with cobbles sub-dominant. The water in Taman Creek during the survey was noted as turbid with numerous salmonid fry present at the downstream end of the site. Algae was abundant throughout the system and eroding banks were common. Abundant gravels suitable for resident rainbow trout and coho salmon spawning were present and habitat was rated as medium value for salmon rearing and spawning.

Figure 5.34: Left: Habitat upstream of PSCIS crossing 197967. Right: Habitat upstream of PSCIS crossing 197967.

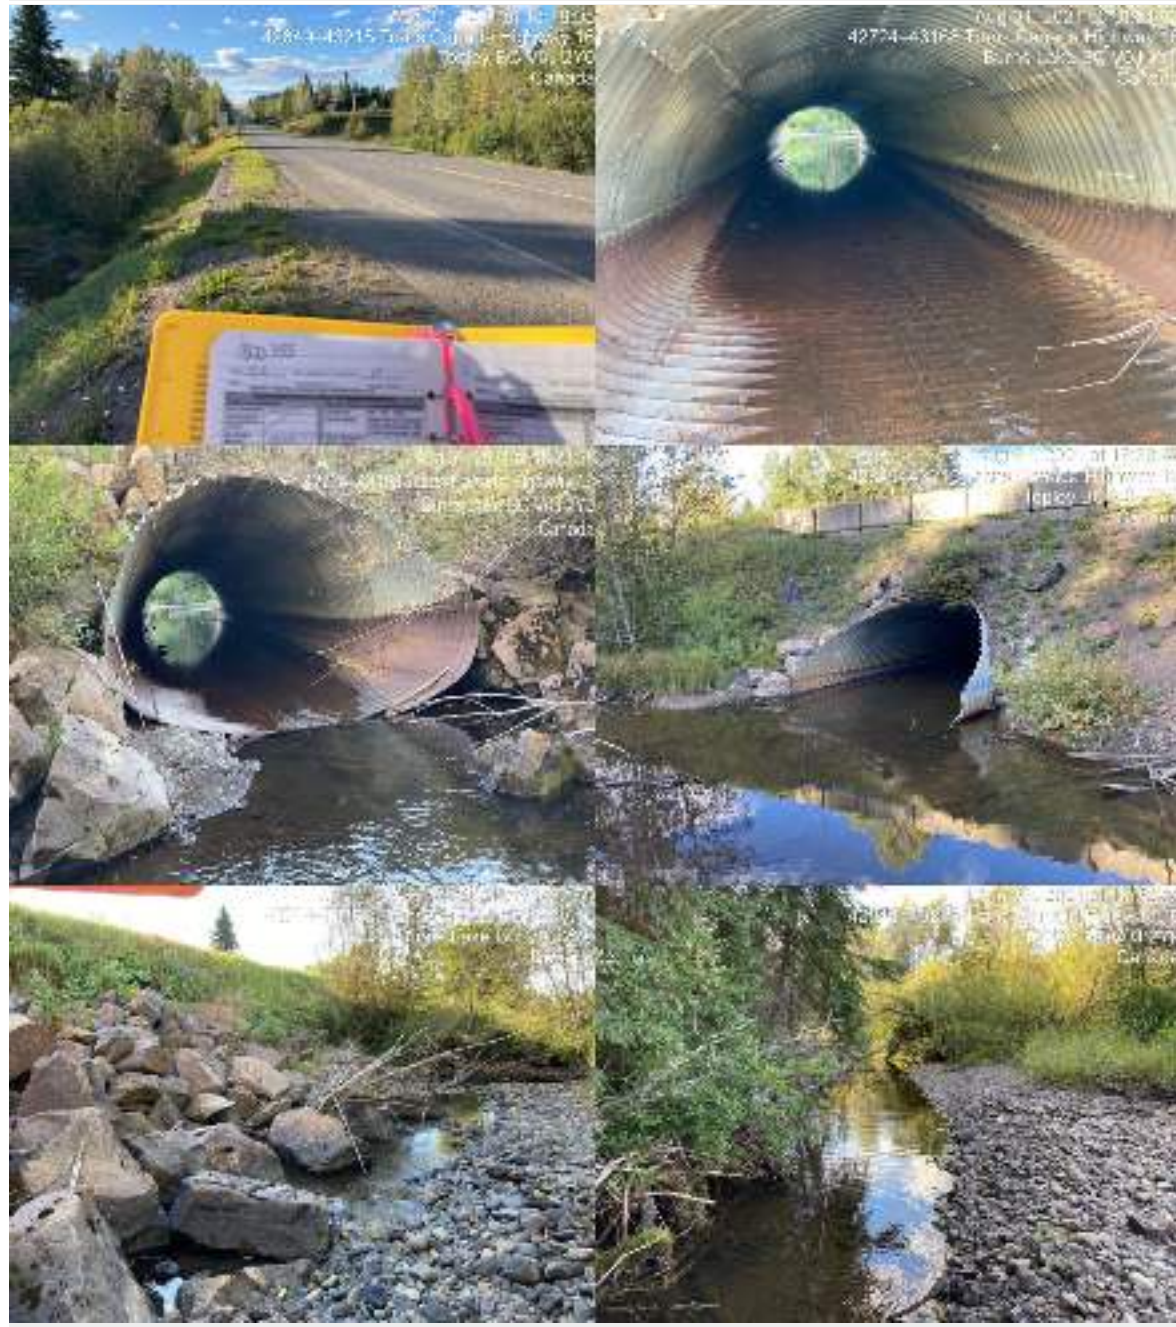
| Location and Stream Data | Crossing Characteristics |
|---|---|
| <p>Comments: Fish sighted upstream, not aligned with stream, channel runs into rip rap berm of highway then over closed bottom structure. Pool (40cn) on upstream inlet. Fish sighted in downstream pool. 18:16</p> | |

Should restoration/maintenance activities proceed, replacement of PSCIS crossing 197976 with a bridge (12.5m span) is recommended. The cost of the work is estimated at \$7,500,000 for a cost benefit of 3.3 linear m/\$1000 and 27.1 m<sup>2</sup>/\$1000. As the crossing partially backwaters naturally, a plan to backwater the crossing could also be of consideration in the short term with a rough cost estimate to complete of \$25,000.

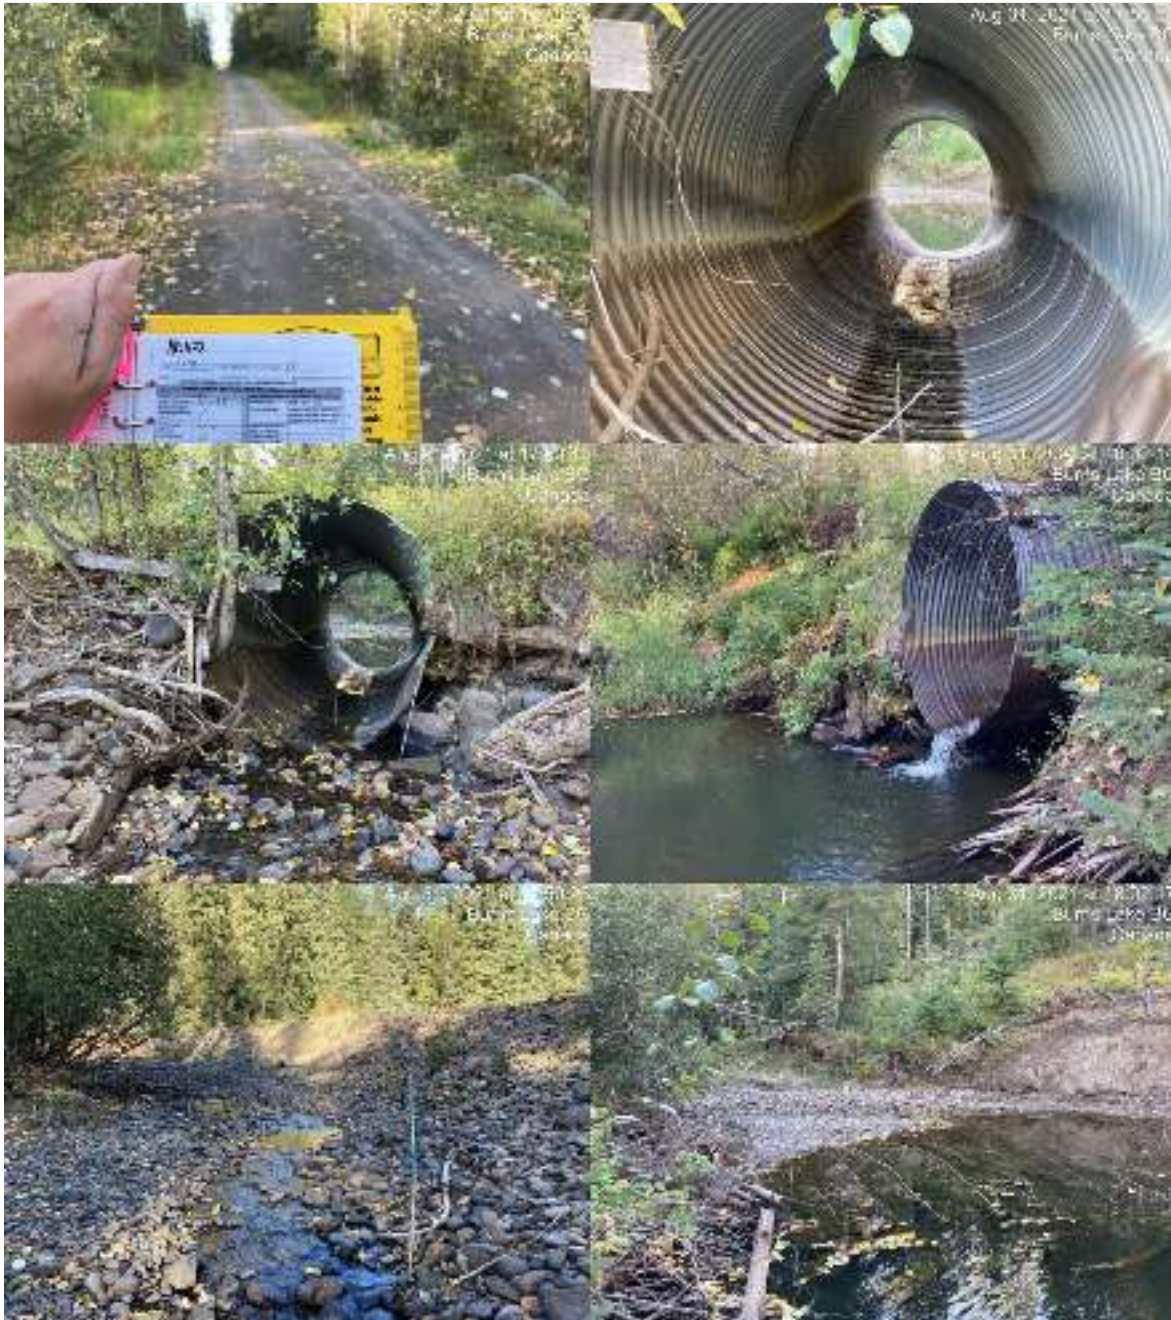
Comments: Dredging upstream, channel width not natural. Signs of major flooding including wear on upstream sides of culvert. No riparian zone on river left upstream. Culvert 4% but has bend at last 2m outlet drop and outlet pool depth are estimates. This stream could use some restoration. 17:46

Should restoration/maintenance activities proceed, replacement of PSCIS crossing 197975 with a bridge (11.5m span) is recommended. The cost of the work is estimated at \$230,000 for a cost benefit of 107.3 linear m/\$1000 and 826.6 m<sup>2</sup>/\$1000. Relocation of the driveway accessing the private land from the other side of the stream and removal of the crossing could also be considered.

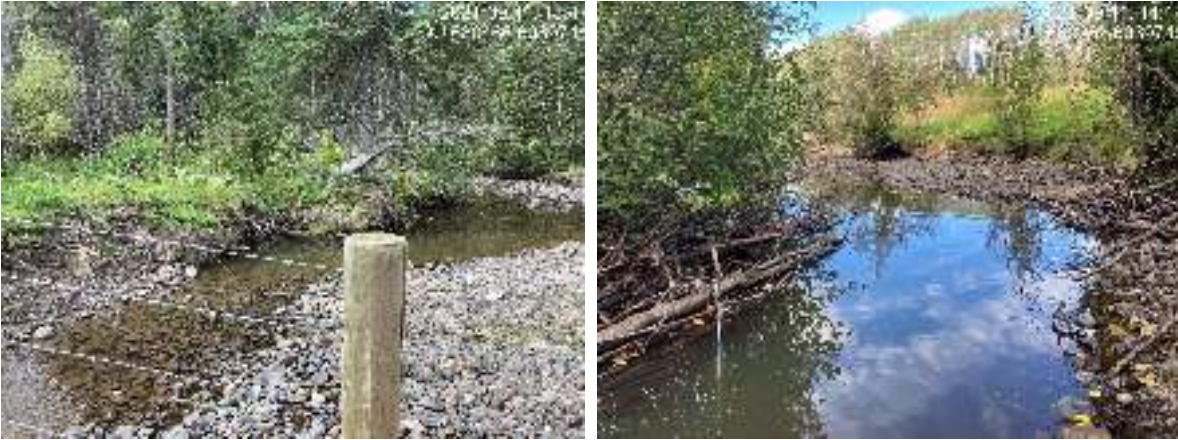
The stream was surveyed downstream from crossing 197976 for 575m (Figure [5.36](#)). The dominant substrate was cobbles with gravels sub-dominant., Total cover amount was rated as moderate with deep pools dominant. Cover was also present as small woody debris, undercut banks, overhanging vegetation, and instream vegetation., The average channel width was 7.7m, the average wetted width was 3.5m, and the average gradient was 1%. Although side channels continued to flow throughout the area surveyed, approximately 160m downstream of the crossing the main channel was dewatered below the location of a beaver dam. Areas of riparian and bank degradation from cattle trampling were noted throughout the area surveyed and there was fencing spanning the channel. Large deposits of substrate and clumped large woody debris piles were observed within widened channel areas indicating disturbance and high flow events. There were abundant gravels present suitable for spawning resident and anadromous salmonids. Habitat was rated as high value for salmonid rearing and spawning with numerous fish observed and numerous deep pools to 0.95m deep.

Figure 5.36: Left: Typical habitat downstream of PSCIS crossing 197976. Right: Typical habitat downstream of PSCIS crossing 197976.

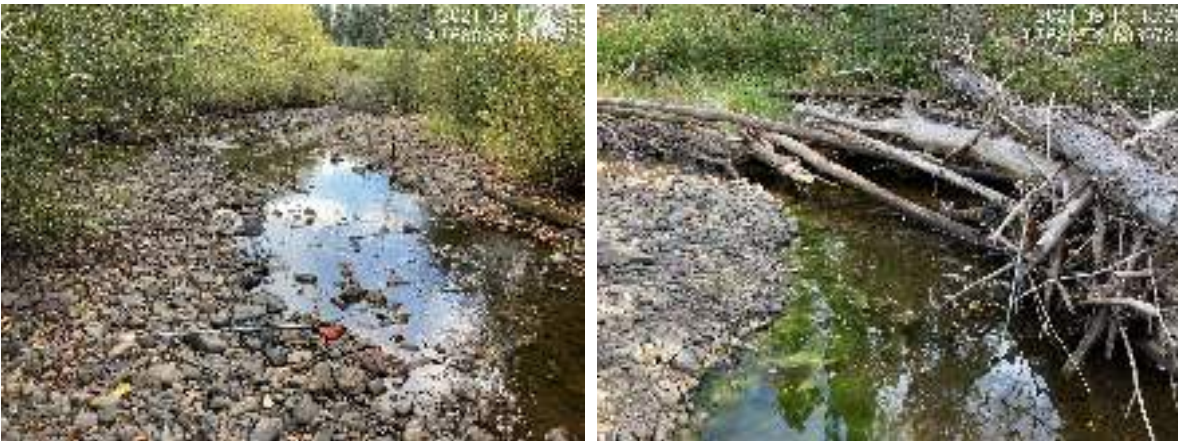
The stream was surveyed upstream from crossing 197976 for 345m (Figure [5.37](#)). The dominant substrate was cobbles with gravels sub-dominant., Total cover amount was rated as moderate with deep pools dominant. Cover was also present as small woody debris, undercut banks, and overhanging vegetation., The average channel width was 8.1m, the average wetted width was 4.2m, and the average gradient was 1%. Fish were observed throughout the area surveyed and extensive algae growth was present on stream substrates. Large woody debris was rare and riparian/bank damage due to livestock was minimal and located at what appeared to be watering sites. Fencing was located across the stream in multiple locations. Patches of gravels suitable for spawning were present. Habitat value was rated as medium as the surveyed area was considered an important migration corridor containing suitable spawning habitat and having moderate rearing potential.

Figure 5.37: Left: Typical habitat upstream of PSCIS crossing 197976. Right: Typical habitat upstream of PSCIS crossing 197976.

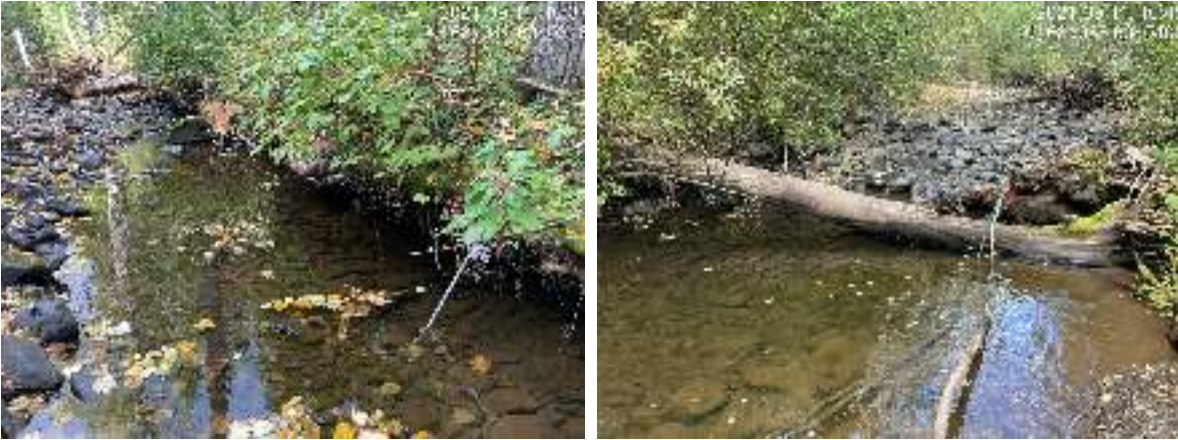
The stream was surveyed upstream from crossing 197975 for 550m (Figure [5.38](#)). Total cover amount was rated as moderate with deep pools dominant. Cover was also present as small woody debris, boulders, undercut banks, and overhanging vegetation., The average channel width was 7.7m, the average wetted width was 3.5m, and the average gradient was 1%., The dominant substrate was cobbles with gravels sub-dominant. Immediately upstream of the crossing for ~80m, extensive anthropogenic damage was noted due to dredging of the channel. Heavy cattle grazing was also observed on the left bank. Juvenile salmonids were observed occasionally throughout the area surveyed. Fencing was located across the stream approximately 250m upstream of the culvert. Patches of gravels suitable for spawning were present. Habitat value was rated as medium as the surveyed area was considered an important migration corridor containing suitable spawning habitat and having moderate rearing potential.

Figure 5.38: Left: Typical habitat upstream of PSCIS crossing 197975. Right: Typical habitat upstream of PSCIS crossing 197975.

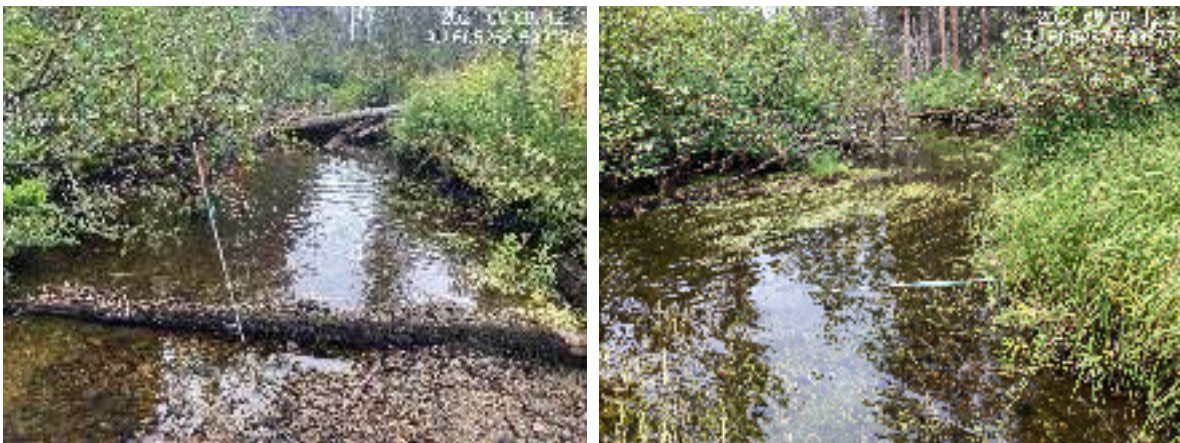
The stream was surveyed downstream from the culvert for 300m (Figure [5.39](#)). Total cover amount was rated as with instream vegetation dominant. Cover was also present as small woody debris, large woody debris, and overhanging vegetation (Table [5.67](#)). The average channel width was 6.2m, the average wetted width was 5.1m and the average gradient was 1.2%. The dominant substrate was gravels with cobbles subdominant. The habitat was rated as high value for salmonid rearing and spawning.

Figure 5.39: Left: Typical habitat downstream of PSCIS crossing 198000. Right: Typical habitat downstream of PSCIS crossing 198000.

Should restoration/maintenance activities proceed at the site, replacement of PSCIS crossing 198000 with a bridge (14m span) is recommended.

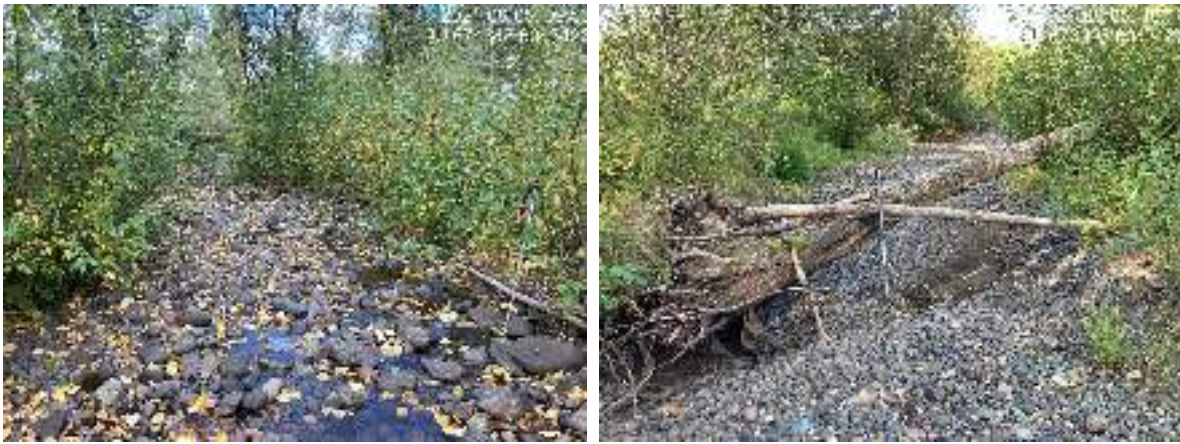
The stream was surveyed downstream from crossing 198048 at Highway 16 for 1400m to the mainstem of the Bulkley River (Figure [5.42](#)). Total cover amount was rated as with overhanging vegetation dominant. Cover was also present as small woody debris and undercut banks (Table [5.73](#)). The average channel width was 5.5m, the average wetted width was 1.5m and the average gradient was 3.5%. The dominant substrate was cobbles with gravels subdominant. The habitat was rated as medium value for salmonid rearing and spawning.

Figure 5.42: Left: Typical habitat downstream of PSCIS crossing 198048. Right: Typical habitat downstream of PSCIS crossing 198048.

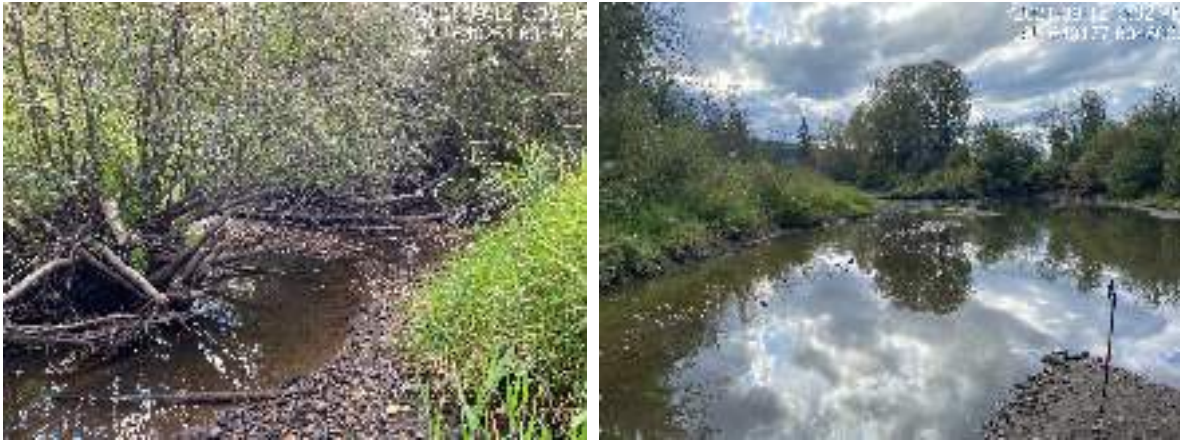
The stream was surveyed downstream from the culvert for 100m (Figure 5.46). Total cover amount was rated as with overhanging vegetation dominant. Cover was also present as (Table 5.78). The

Figure 5.46: Left: Typical habitat downstream of PSCIS crossing 198066. Right: Habitat on side channel of Bulkley River downstream of crossing 198066.
