Improving the Prospects for Shallow Water Wetlands  
through Upland Vegetation Management in the  
Stuart Nechako Resource District

**sern** Society for Ecosystem Restoration  
in North Central British Columbia

**T. Kaffanke Consulting Ltd.**

March, 2016

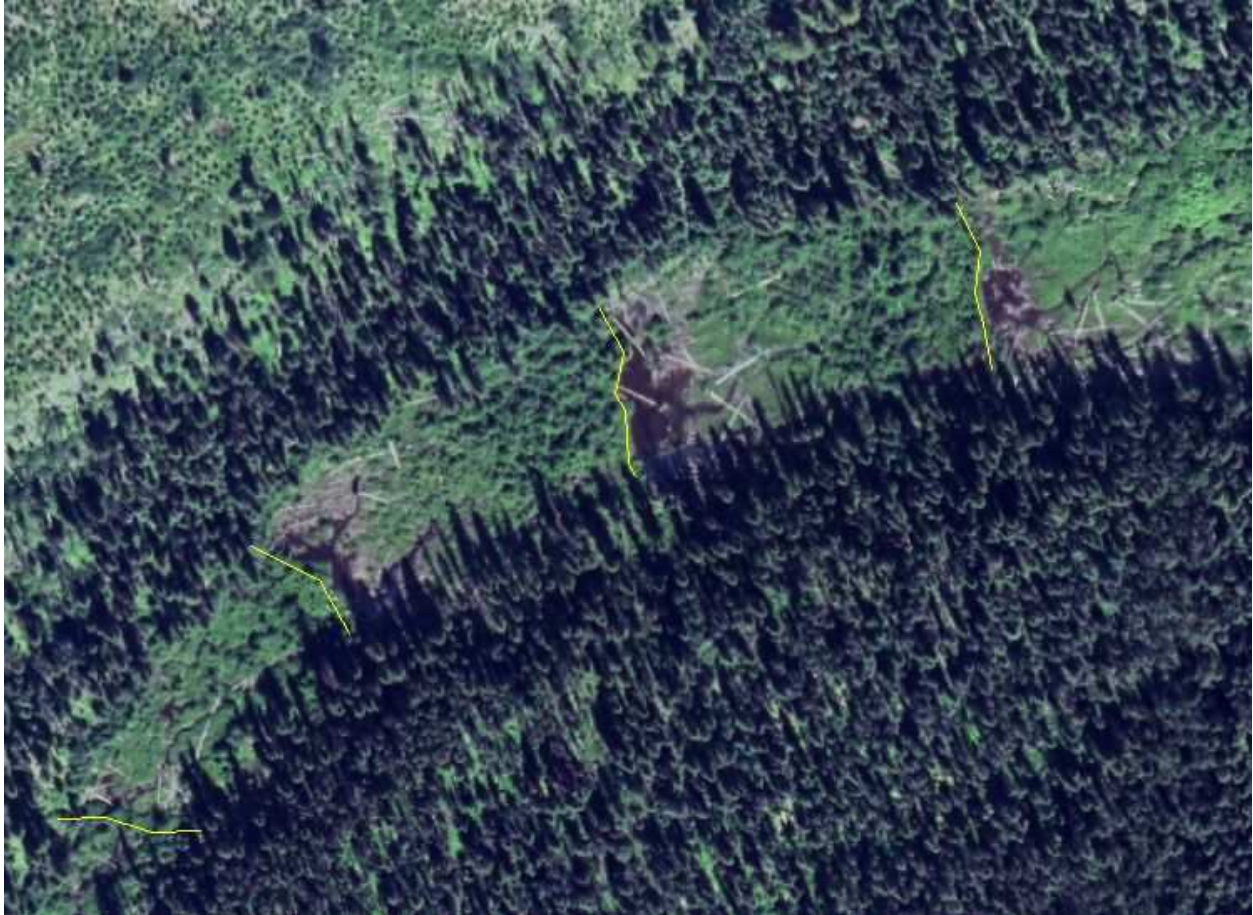
*Figure 1. Four abandoned and breached dams (West arm Kluk Creek), highlighted with yellow lines, appear in this image. Three of the dams have remnants of their former ponds immediately upstream.*

Figure 1 shows a stream reach with four long-abandoned, deeply breached dams with only remnants of the ponds remaining. Often, these remnant ponds are a linear feature on the upstream side of the dam and persist only because they were excavated by beavers to provide earth to seal the dam. In this example, the drawn-down ponds, referred to as “beaver meadows”, are about 50 m wide.

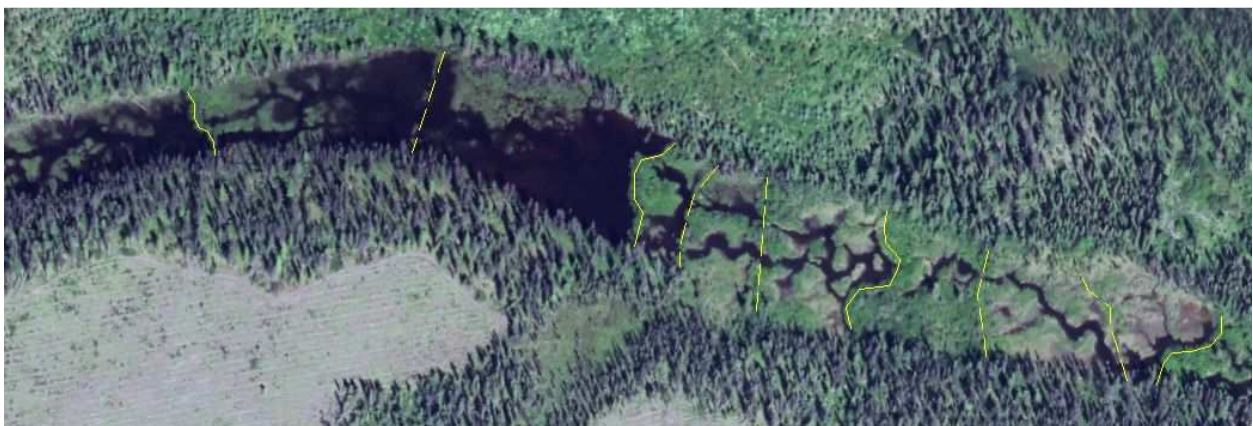
*Figure 2. Both active and abandoned dams appear in this image (Nine Mile Creek). Solid lines are confirmed dam locations, dashed are inferred. Pond width is about 50 m. (Rightmost dam restored since the image was made in 2012.)*

In Figure 2, the solid yellow lines indicate confirmed dam locations, and the dashed lines are inferred. The left half of the image shows ponds behind actively maintained dams, while the right half shows where abandoned, breached dams have lowered pond levels.

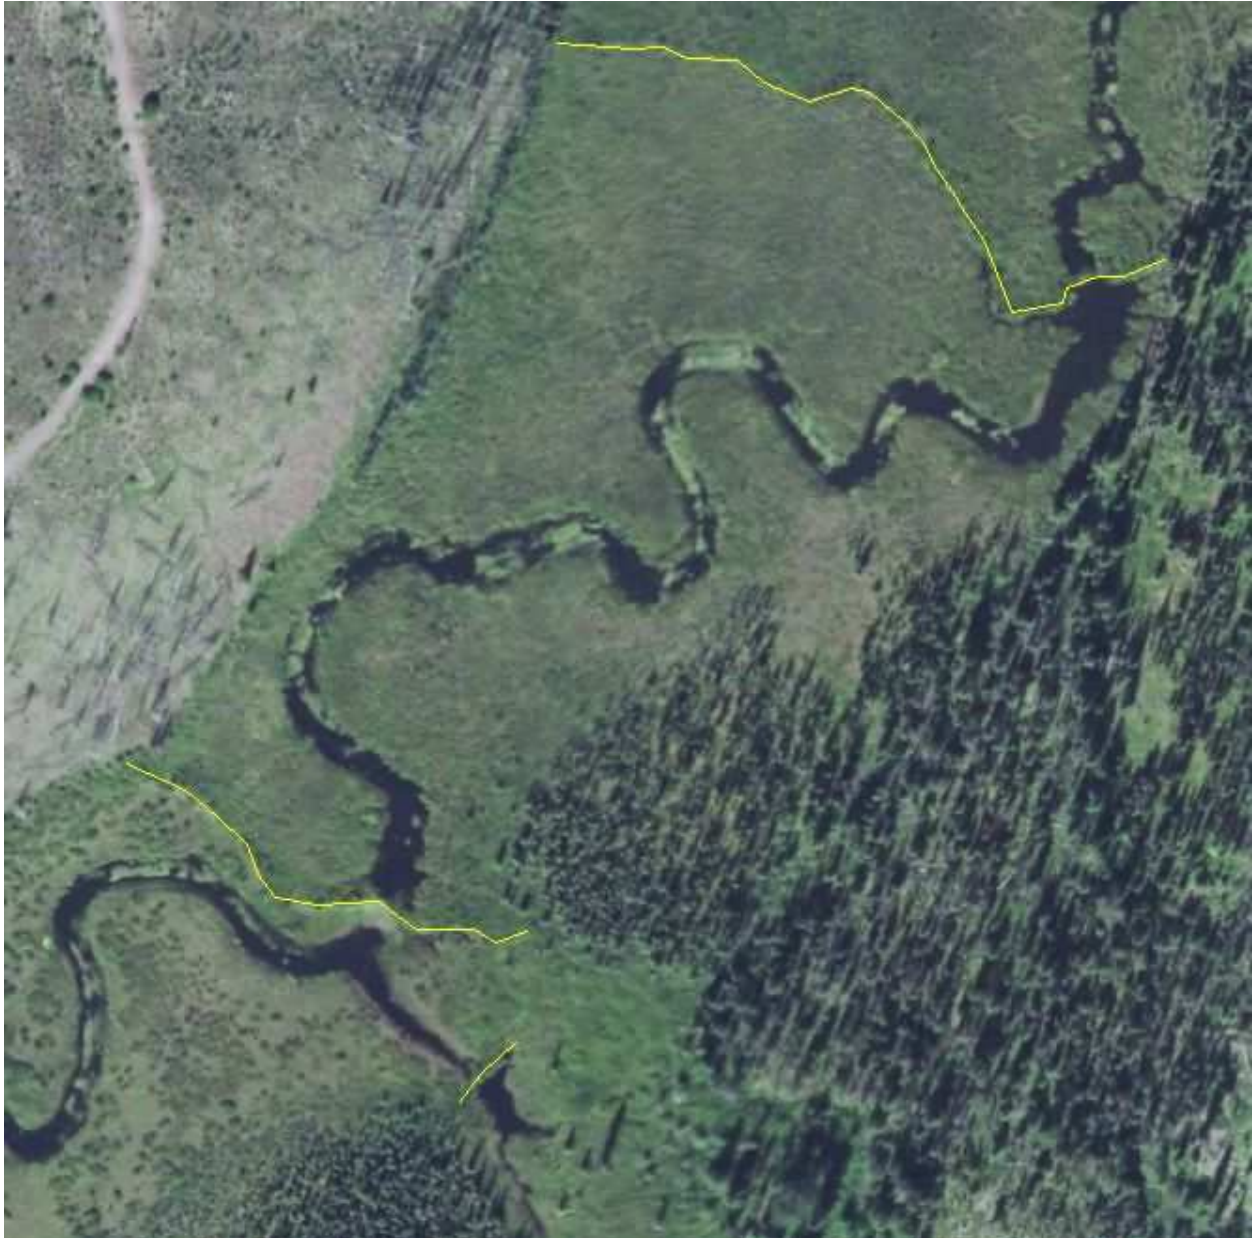
Figure 3. Three old abandoned and breached dams (Cutoff Creek). The longest is about 200 m long. The shortest is across a tributary of the larger channel.

Figure 3 shows three old abandoned and breached dams on Cutoff Creek. The longest of these is approximately 200 m long.

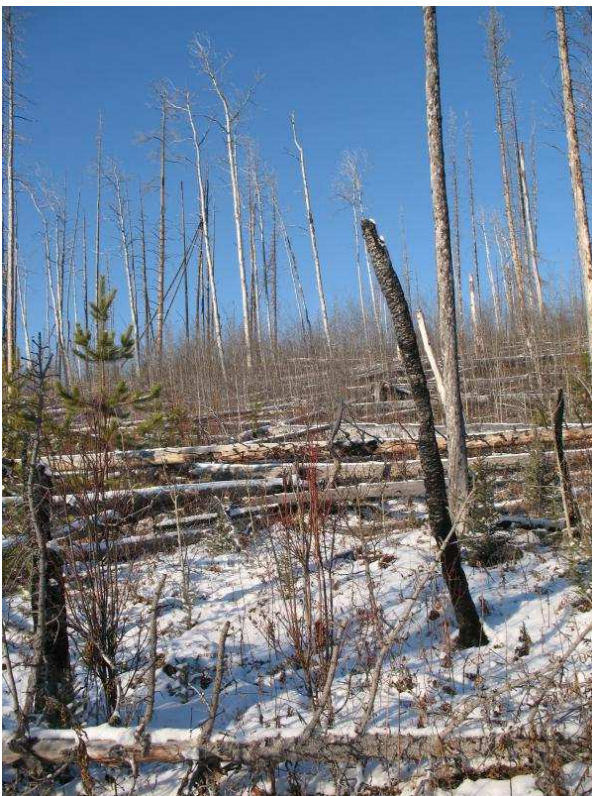
*Figure 7. Aspen suckers occur to within 12-15 m of wetland margin, well downslope of the mature stems that were killed by the Kenney Dam Fire.*

Figure 7 illustrates an example from the Kenney Dam Fire where aspen suckers originating from large dead stems upslope are present about 12-15 m from the wetland margin. They are heavily browsed near the water, but 15 m upslope many have escaped browsing. All but one of the large old stems are near the first slope break. This reveals much about the regenerative potential for many other areas where live large aspen are only found a long distance upslope. Figure 8 shows the downslope density of non-browsed aspen suckers in the vicinity of two large, fire-killed stems. Elsewhere, dense clones were present without nearby aspen snags, which may have fallen since the fire, or may indicate suckering from small residual understory stems sometimes found amongst conifers.

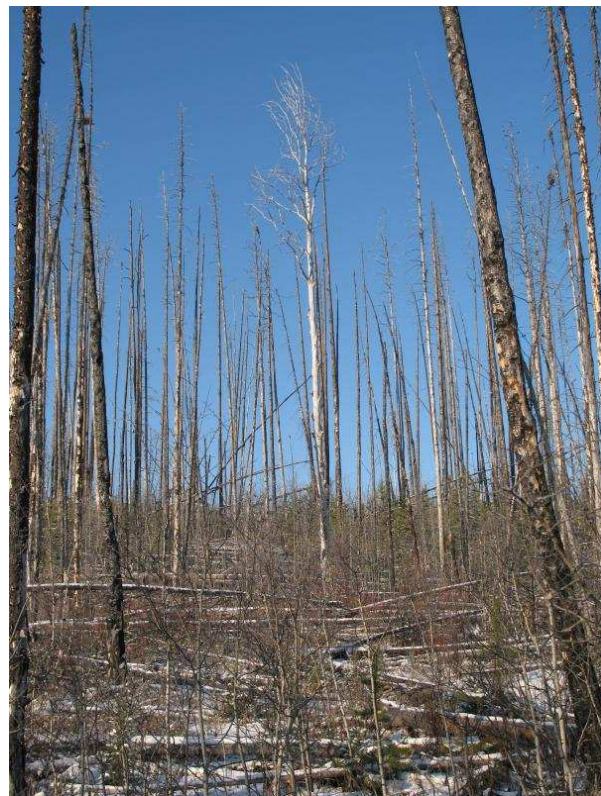
*Figure 8. Two large aspen killed in the Kenney Dam Fire are the source of a large area of suckers, not browsed, and within easy distance of water if the adjacent pond level is raised.*

By 2015, beavers had begun to recolonize this area and were exploiting the largest of the suckers originating from the fire. It should also be noted that this fire was a landscape level event that abruptly altered the vegetation over a large area. A consequence of this scale of event is that while browsing by moose does occur on aspen suckers, many stems escape browsing to grow beyond shrub size, eventually suitable for exploitation by beaver.
